Access Compliance Report Public Rights-of-Way (Curb Ramps)

Intersection ID: 10777 Main Street: WESLEY AV **Cross Street: WHITING AV** Location: NW Initial Pass/Fail: Fail **Overall Compliance: No** ADA ID: 5E501973967B Ramp Type: Directional1 Severity Score: 13.75

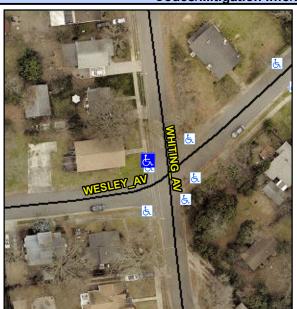
WESLEY AV Street 1 Name Stop Condition-Street 1 StopSign N/A Street 2 Name Stop Condition-Street 2 N/A Possible Solutions: Compliance Description N/A Remove & Replace Entire Ramp. Yes No No N/A N/A Surveyor Notes: N/A N/A N/A N/A N/A N/A PROW/ADA: N/A R304.2.2, R304.5.3 N/A N/A N/A N/A
