Access Compliance Report

Public Rights-of-Way (Curb Ramps)

Intersection ID: 5822	Main Street: GUM_BRANCH_RD	Cross Street: MELLWOOD_DR	Location: W
ADA ID: 5E547F637C5C	Ramp Type: Directional1	Initial Pass/Fail: Fail	Overall Compliance: No
		Severity Score: 1.25

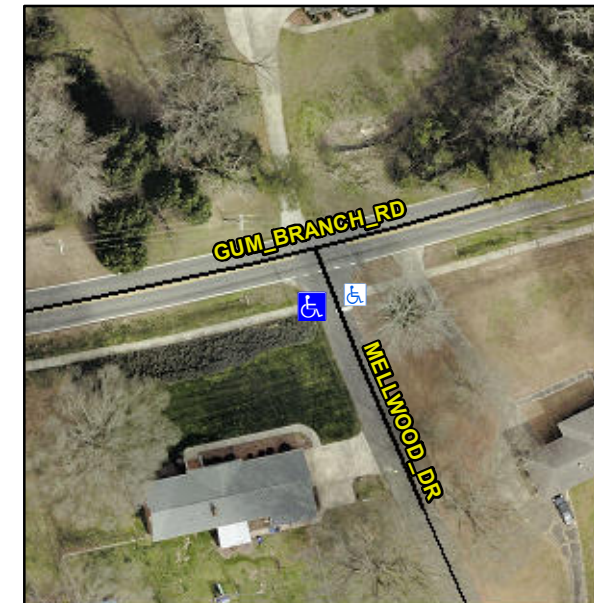
Compliance	Description	Data	Compliance	Description	Data
N/A	Ramp Length (in)	52.0	N/A	Grade Break?	N/A
Yes	Ramp Width (in)	60.0	N/A	Grade Break Slope (%)	0.0
Yes	Ramp Slope (%)	5.8	N/A	Grade Break XSlope (%)	0.0
No	Ramp XSlope (%)	4.5			
N/A	Flare Type LT	N/A	N/A	Flare Type RT	N/A
N/A	Flare Slope LT (%)	N/A	N/A	Flare Slope RT (%)	0.0
N/A	Flare Traversable LT?	N/A	N/A	Flare Traversable RT?	N/A
N/A	Landing Length (in)	0.0	N/A	DWS Provided?	N/A
N/A	Landing Width (in)	0.0	N/A	DWS Contrast?	N/A
N/A	Landing Slope (%)	0.0	N/A	DWS Length (in)	N/A
N/A	Landing X Slope (%)	0.0	N/A	DWS Full Width?	N/A
N/A	Landing Curb? (Y/N)	N/A	N/A	DWS Offset LT (in)	N/A
N/A	Shared Landing?	N/A	N/A	DWS Offset RT (in)	N/A
N/A	Gutter Ponding?	0.0	N/A	Gutter Slope (%)	N/A
N/A	Gutter Lip Ht (in)	0.0	N/A	Gutter X Slope (%)	N/A
N/A	Painted X Walk1?	No		Road Slope (%)	5.9
	X Walk 1 Direction	To E		Road X Slope (%)	5.6
	X Walk 1 Width (in)	N/A		Clear Space?	N/A

X Walk 1 Slope (%)	5.9	N/A	Clear Space to XWalk (in)	N/A
	X Walk 1 X Slope (%)	5.6	N/A	Storm Grate/Utility Hazard?	N/A
N/A	Ramp inside XWalk1?	N/A		Storm Grate/Utility Type	
N/A	Any Obstructions?	N/A			N/A
	Obstruction Type		Yes	Surface Condition? (G/P)	Good
			N/A	Curb Slope (%)	2.2

Remove & Replace Entire Ramp.
