Access Compliance Report

Public Rights-of-Way

(Curb Ramps)

Intersection ID: N/A	Main Street: E_4TH_ST	Cross Street: S_COLLEGE_ST	Location: S
ADA ID: 5E5B7B687121	Ramp Type: Perp	Initial Pass/Fail: Pass	Overall Compliance: No
			Severity Score: 2.75
Codes/Mitigation Info/Possible Solution		Field Measurements/Component Compliance

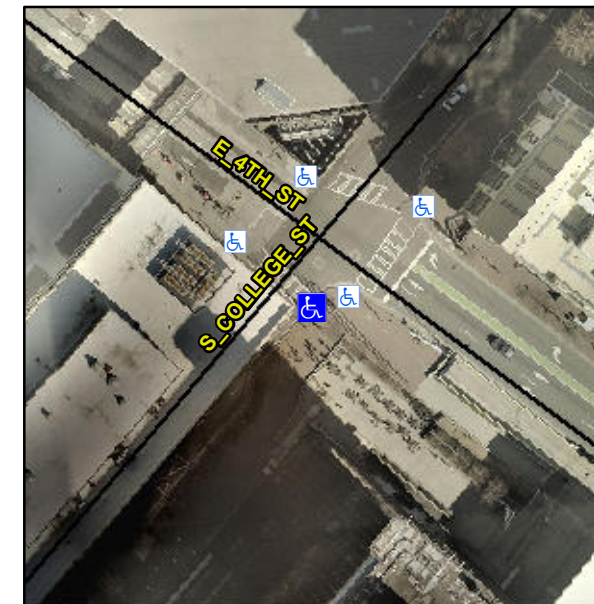
Compliance	Description	Data	Compliance	Description	Data
N/A	Ramp Length (in)	103.0	Yes	Ramp Slope (%)	6.8
Yes	Ramp Width (in)	48.0	No	Ramp XSlope (%)	2.1
N/A	Flare Type LT	Sloped	N/A	Flare Type RT	N/A
N/A	Flare Slope LT (%)	10.9	Yes	Flare Slope RT (%)	7.2
N/A	Flare Traversable LT?	Yes	N/A	Flare Traversable RT?	Yes
Yes	Landing Length (in)	60.0	Yes	DWS Provided?	Yes
Yes	Landing Width (in)	60.0	Yes	DWS Contrast?	Yes
No	Landing Slope (%)	2.7	Yes	DWS Length (in)	24.0
Yes	Landing X Slope (%)	0.6	Yes	DWS Full Width?	Yes
N/A	Landing Curb? (Y/N)	No	Yes	DWS Offset (in)	0.0
N/A	Shared Landing?	No			
Yes	Gutter Ponding?	No	Yes	Gutter Slope (%)	4.8
Yes	Gutter Lip Ht (in)	0.0	No	Gutter X Slope (%)	2.4
N/A	Painted X Walk1?	Yes	N/A	Painted X Walk2?	N/A
	X Walk 1 Direction	To NW		X Walk 2 Direction	N/A
N/A	X Walk 1 Width (in)	108.0	N/A	X Walk 2 Width (in)	N/A
	X Walk 1 Slope (%)	3.4		X Walk 2 Slope (%)	N/A
	X Walk 1 X Slope (%)	1.8		X Walk 2 X Slope (%)	N/A

Yes	Ramp inside XWalk1?	Yes	N/A	Ramp inside XWalk2?	N/A
	Road Slope (%)	N/A	N/A	Clear Space?	Yes
	Road X Slope (%)	N/A	N/A	Clear Space to XWalk (in)	N/A
Yes	Any Obstructions?	No	Yes	Storm Grate/Utility Hazard?	No
	Obstruction Type			Storm Grate/Utility Type	
		N/A			N/A
			Yes	Surface Condition? (G/P)	Good

Possible Solutions:

**Remove & Replace Entire Ramp.
Remove & Replace Gutter.**

R304.5.3, R304.2.2-Perp, R304.3.2-Para, R304.2.3

Total Cost: \$ 2600.00

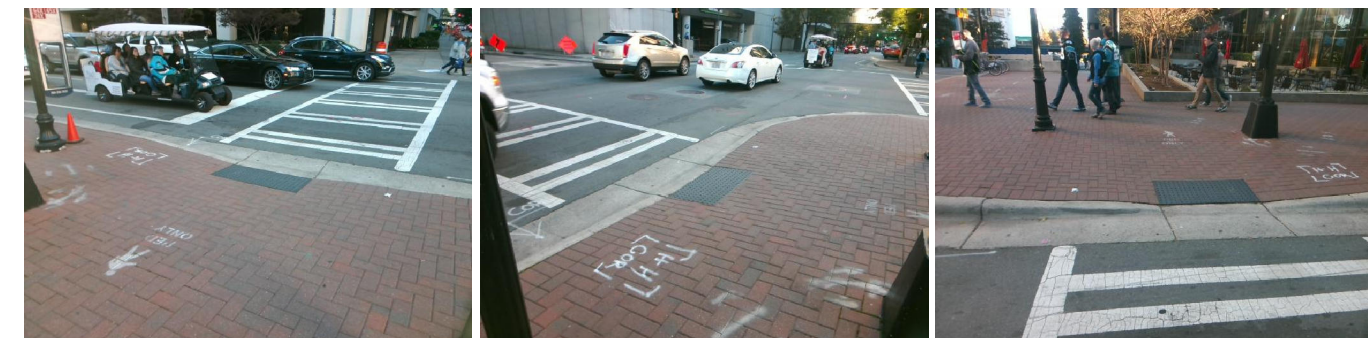
Street 1 Name	S COLLEGE ST
Stop Condition-Street 2	Signal
Street 2 Name	N/A
Stop Condition-Street 1	N/A
