Access Compliance Report

Public Rights-of-Way

(Curb Ramps)

| Intersection ID: 49149 | Main Street: OLD_PROVIDENCE_LN | Cross Street: DACAVIN_DR | Location: SE |

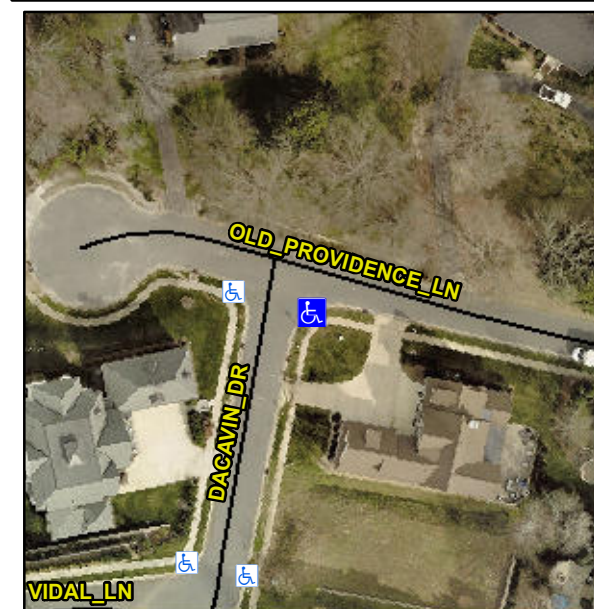
Not Found, R304.5.1

| Compliance | Description | Data | Compliance | Description | Data |
|---|---|---|---|---|---|
| N/A | Ramp Length (in) | 47.0 | Yes | Ramp Slope (%) | 7.9 |
| No | Ramp Width (in) | 46.5 | Yes | Ramp XSlope (%) | 1.2 |

Remove & Replace Curb Ramp With Two New Directional Ramps or Equivalent.
