Access Compliance Report

Public Rights-of-Way

(Curb Ramps)

Intersection ID: 20750	Main Street: LANSDOWNE_RD	Cross Street: PRETT_CT	Location: S
ADA ID: 5E600AC28D93	Ramp Type: PerpDiag	Initial Pass/Fail: Fail	Overall Compliance: No
			Severity Score: 13.75

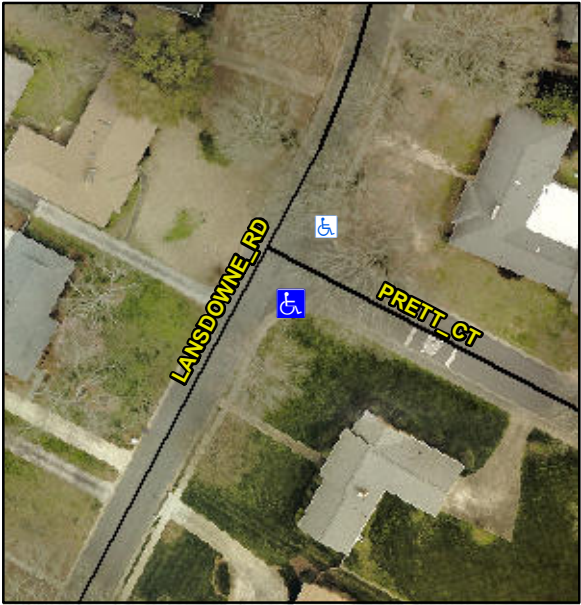
Possible Solutions:		Compliance	Description	Data
	Remove & Replace Curb Ramp With Two New Directional Ramps or Equivalent.		No	Ramp Length (in)	47.0
			Yes	Ramp Width (in)	78.0
			N/A	Flare Type LT	N/A
			N/A	Flare Slope LT (%)	N/A
			N/A	Flare Traversable LT?	N/A
			N/A	Landing Length (in)	N/A
			N/A	Landing Width (in)	N/A
			N/A	Landing Slope (%)	N/A
			N/A	Landing X Slope (%)	N/A
<p>Surveyor Notes:</p> <p>N/A</p> <p>PROW/ADA:</p> <p>Not Found, R304.2.2, R304.5.3</p>			N/A	Flare Type RT	N/A
			N/A	Flare Slope RT (%)	N/A
			N/A	Flare Traversable RT?	N/A
			N/A	DWS Provided?	N/A
			N/A	DWS Contrast?	N/A
			N/A	DWS Length (in)	N/A
			N/A	DWS Full Width?	N/A
			N/A	DWS Offset (in)	N/A
			N/A	Gutter Ponding?	N/A
			N/A	Gutter Lip Ht (in)	N/A
<p>Total Cost:</p> <p>\$ 3200.00</p>			No	Painted X Walk2?	No
			To NE	X Walk 2 Direction	To NW

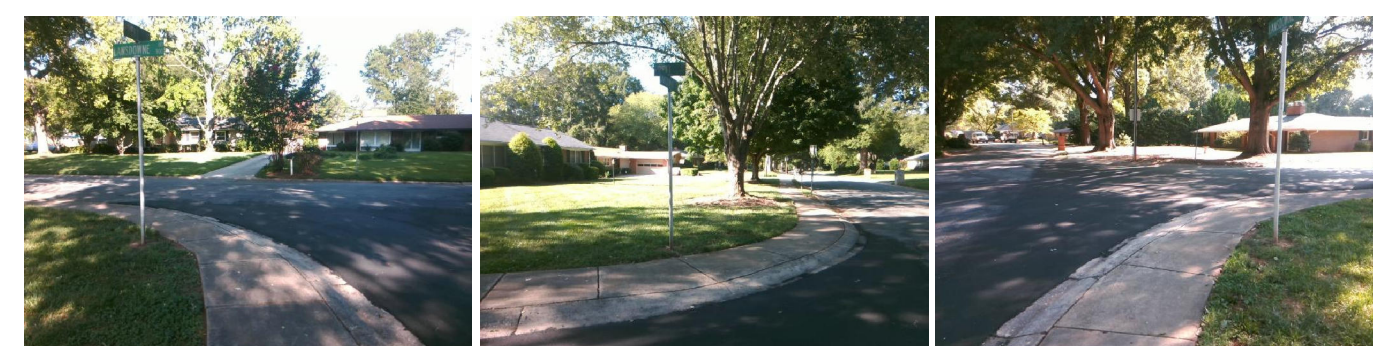
N/A	X Walk 2 Width (in)	N/A
			1.5	X Walk 2 Slope (%)	1.5
			0.8	X Walk 2 X Slope (%)	1.7
			N/A	Ramp inside XWalk2?	N/A
			1.0	Clear Space?	N/A
			6.8	Clear Space to XWalk (in)	N/A
			N/A	Storm Grate/Utility Hazard?	N/A
			N/A	Storm Grate/Utility Type	N/A
<p>Street 1 Name</p> <p>PRETT CT</p> <p>Stop Condition-Street 2</p> <p>StopSign</p> <p>Street 2 Name</p> <p>LANSDOWNE RD</p> <p>Stop Condition-Street 1</p> <p>None</p>			N/A	Surface Condition? (G/P)	Good
			N/A
