Access Compliance Report Public Rights-of-Way (Curb Ramps)

Intersection ID: 3798 Main Street: MARTINDALE_LN Cross Street: RHIAN_BROOK_LN Location: N **Overall Compliance: No Severity Score:** ADA ID: 5E773515F140 Ramp Type: Perp Initial Pass/Fail: Fail 12.5

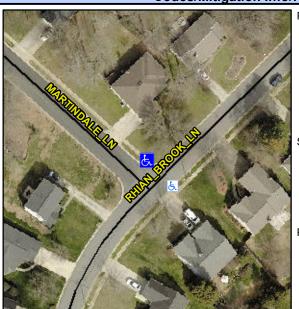
Field Measurements/Component Compliance							
Comp	liance Description	Data	Comp	liance Description	Data		
N/A	Ramp Length (in)	30.0	Yes	Ramp Slope (%)	6.0		
Yes	Ramp Width (in)	48.0	No	Ramp XSlope (%)	6.3		
N/A	Flare Type LT	N/A	N/A	Flare Type RT	N/A		
N/A	Flare Slope LT (%)	N/A	N/A	Flare Slope RT (%)	N/A		
N/A	Flare Traversable LT?	N/A	N/A	Flare Traversable RT?	N/A		
N/A	Landing Length (in)	N/A	N/A	DWS Provided?	N/A		
N/A	Landing Width (in)	N/A	N/A	DWS Contrast?	N/A		
N/A	Landing Slope (%)	N/A	N/A	DWS Length (in)	N/A		
N/A	Landing X Slope (%)	N/A	N/A	DWS Full Width?	N/A		
N/A	Landing Curb? (Y/N)	N/A	N/A	DWS Offset (in)	N/A		
N/A	Shared Landing?	N/A					
N/A	Gutter Ponding?	N/A	N/A	Gutter Slope (%)	N/A		
N/A	Gutter Lip Ht (in)	N/A	N/A	Gutter X Slope (%)	N/A		
N/A	Painted X Walk1?	No	N/A	Painted X Walk2?	N/A		
	X Walk 1 Direction	To S		X Walk 2 Direction	N/A		
N/A	X Walk 1 Width (in)	N/A	N/A	X Walk 2 Width (in)	N/A

X Walk 1 Slope (%)	4.0		X Walk 2 Slope (%)	N/A		
	X Walk 1 X Slope (%)	1.8		X Walk 2 X Slope (%)	N/A		
N/A	Ramp inside XWalk1?	N/A	N/A	Ramp inside XWalk2?	N/A		
	Road Slope (%)	N/A	N/A	Clear Space?	N/A		
	Road X Slope (%)	N/A	N/A	Clear Space to XWalk (in)	N/A		
N/A	Any Obstructions?	N/A	N/A	Storm Grate/Utility Hazard?	N/A		
	Obstruction Type			Storm Grate/Utility Type			
		N/A			N/A		
			Yes	Surface Condition? (G/P)	Good		
13	MILION MILION

Possible Solution	
Possible Solutions:	C
Remove & Replace Entire Ramp.	N/
•	Ye
	N/
	N/
	N/
	N/
Surveyor Notes:	N/
N/A	N/
	N/
	N/
	N/
PROW/ADA:	N/
Not Found, R304.5.3	N/
	N/
	N/

Total Cost: 1850.00
