Access Compliance Report

Public Rights-of-Way

(Curb Ramps)

Intersection ID: 8047	Main Street: N_HOSKINS_RD	Cross Street: ROZZELLES_FERRY_RD	Location: N
ADA ID: 5E7AAE0735EA	Ramp Type: Perp	Initial Pass/Fail: Fail	Overall Compliance: No
		Severity Score: 8.75

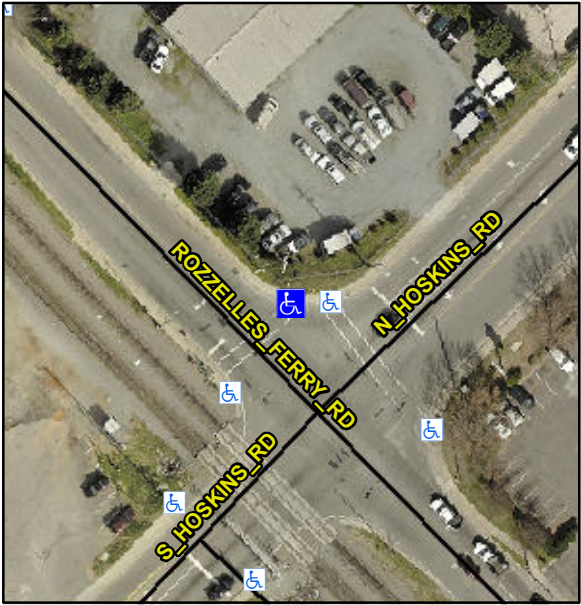
Possible Solutions:		Compliance	Description	Data
	Remove & Replace Entire Ramp.		Yes	Ramp Length (in)	59.0
			No	Ramp Width (in)	41.0
			N/A	Flare Type LT	N/A
			N/A	Flare Slope LT (%)	N/A
			N/A	Flare Traversable LT?	N/A
			N/A	Landing Length (in)	N/A
			N/A	Landing Width (in)	N/A
			N/A	Landing Slope (%)	N/A
			N/A	Landing X Slope (%)	N/A
<p>Surveyor Notes:</p> <p>N/A</p> <p>PROW/ADA:</p> <p>Not Found, R304.5.1</p>			N/A	Flare Type RT	N/A
			N/A	Flare Slope RT (%)	N/A
			N/A	Flare Traversable RT?	N/A
			N/A	DWS Provided?	N/A
			N/A	DWS Contrast?	N/A
			N/A	DWS Length (in)	N/A
			N/A	DWS Full Width?	N/A
			N/A	DWS Offset (in)	N/A
			N/A	Shared Landing?	N/A
			N/A	Gutter Ponding?	N/A
			N/A	Gutter Lip Ht (in)	N/A
			N/A	Painted X Walk1?	No
				X Walk 1 Direction	To SW
			N/A	X Walk 1 Width (in)	N/A
				X Walk 1 Slope (%)	4.5
				X Walk 1 X Slope (%)	0.7

N/A	Ramp inside XWalk1?	N/A
			N/A	Ramp inside XWalk2?	N/A
			N/A	Road Slope (%)	N/A
			N/A	Road X Slope (%)	N/A
			N/A	Any Obstructions?	N/A
				Obstruction Type	
			N/A	Clear Space?	N/A
			N/A	Clear Space to XWalk (in)	N/A
			N/A	Storm Grate/Utility Hazard?	N/A
				Storm Grate/Utility Type	
			N/A		N/A
			Yes	Surface Condition? (G/P)	Good
