Access Compliance Report

Public Rights-of-Way

(Curb Ramps)

Intersection ID: N/A	Main Street: PINEVILLE-MATTHEWS_RD	Cross Street: CHALLIS_FARM_RD	Location: NE
ADA ID: 5E820BF89364	Ramp Type: PerpDiag	Initial Pass/Fail: Fail	Overall Compliance: No
Severity Score: 25			
Codes/Mitigation Info/Possible Solution		Field Measurements/Component Compliance

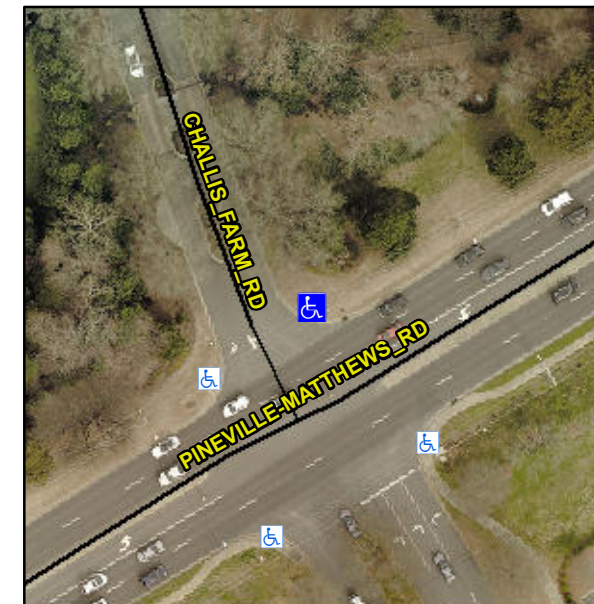
Not Found, R304.5.3

Compliance	Description	Data	Compliance	Description	Data
N/A	Ramp Length (in)	49.0	Yes	Ramp Slope (%)	5.2
Yes	Ramp Width (in)	48.0	No	Ramp XSlope (%)	7.0
N/A	Flare Type LT	N/A	N/A	Flare Type RT	N/A
N/A	Flare Slope LT (%)	N/A	N/A	Flare Slope RT (%)	N/A
N/A	Flare Traversable LT?	N/A	N/A	Flare Traversable RT?	N/A
N/A	Landing Length (in)	N/A	N/A	DWS Provided?	N/A
N/A	Landing Width (in)	N/A	N/A	DWS Contrast?	N/A
N/A	Landing Slope (%)	N/A	N/A	DWS Length (in)	N/A
N/A	Landing X Slope (%)	N/A	N/A	DWS Full Width?	N/A
N/A	Landing Curb? (Y/N)	N/A	N/A	DWS Offset (in)	N/A
N/A	Shared Landing?	N/A			
N/A	Gutter Ponding?	N/A	N/A	Gutter Slope (%)	N/A
N/A	Gutter Lip Ht (in)	N/A	N/A	Gutter X Slope (%)	N/A
N/A	Painted X Walk1?	No	N/A	Painted X Walk2?	No
	X Walk 1 Direction	To W		X Walk 2 Direction	To SW
N/A	X Walk 1 Width (in)	N/A	N/A	X Walk 2 Width (in)	N/A
	X Walk 1 Slope (%)	1.5		X Walk 2 Slope (%)	6.2
	X Walk 1 X Slope (%)	7.1		X Walk 2 X Slope (%)	1.3

N/A	Ramp inside XWalk1?	N/A	N/A	Ramp inside XWalk2?	N/A
	Road Slope (%)	5.7	N/A	Clear Space?	N/A
	Road X Slope (%)	3.1	N/A	Clear Space to XWalk (in)	N/A
N/A	Any Obstructions?	N/A	N/A	Storm Grate/Utility Hazard?	N/A
	Obstruction Type			Storm Grate/Utility Type	
		N/A			N/A
		Yes		Surface Condition? (G/P)	Good

Possible Solutions:

Remove & Replace Curb Ramp With Two New Directional Ramps or Equivalent.
