Access Compliance Report

Public Rights-of-Way

(Curb Ramps)

Intersection ID: N/A	Main Street: COPPER_WY	Cross Street: N/A	Location: SE
ADA ID: 5E82EB8C907C	Ramp Type: PerpDiag	Initial Pass/Fail: Fail	Overall Compliance: No
			Severity Score: 21.25

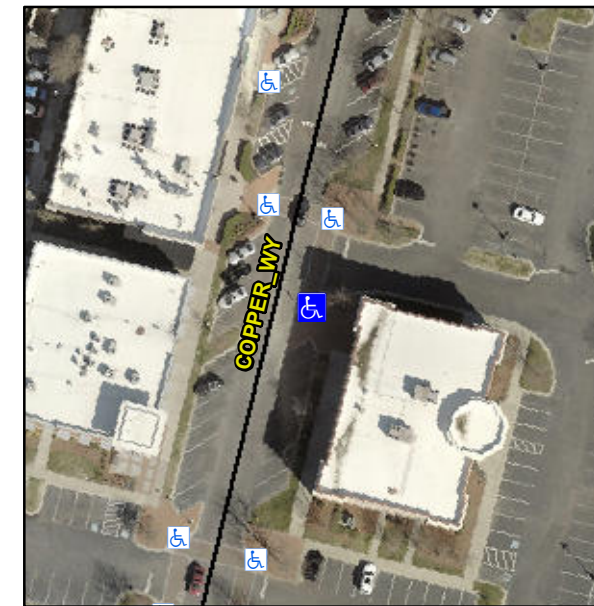
Compliance	Description	Data	Compliance	Description	Data
N/A	Ramp Length (in)	66.0	No	Ramp Slope (%)	9.9
No	Ramp Width (in)	44.0	Yes	Ramp XSlope (%)	0.2
N/A	Flare Type LT	N/A	N/A	Flare Type RT	N/A
N/A	Flare Slope LT (%)	N/A	N/A	Flare Slope RT (%)	N/A
N/A	Flare Traversable LT?	N/A	N/A	Flare Traversable RT?	N/A
N/A	Landing Length (in)	N/A	N/A	DWS Provided?	N/A
N/A	Landing Width (in)	N/A	N/A	DWS Contrast?	N/A
N/A	Landing Slope (%)	N/A	N/A	DWS Length (in)	N/A
N/A	Landing X Slope (%)	N/A	N/A	DWS Full Width?	N/A
N/A	Landing Curb? (Y/N)	N/A	N/A	DWS Offset (in)	N/A
N/A	Shared Landing?	N/A			
N/A	Gutter Ponding?	N/A	N/A	Gutter Slope (%)	N/A
N/A	Gutter Lip Ht (in)	N/A	N/A	Gutter X Slope (%)	N/A
N/A	Painted X Walk1?	Yes	N/A	Painted X Walk2?	No
	X Walk 1 Direction	To NE		X Walk 2 Direction	To NW
N/A	X Walk 1 Width (in)	101.0	N/A	X Walk 2 Width (in)	N/A
	X Walk 1 Slope (%)	0.0		X Walk 2 Slope (%)	0.1
	X Walk 1 X Slope (%)	1.0		X Walk 2 X Slope (%)	0.6

N/A	Ramp inside XWalk1?	Yes	N/A	Ramp inside XWalk2?	N/A
	Road Slope (%)	0.2	N/A	Clear Space?	N/A
	Road X Slope (%)	1.3	N/A	Clear Space to XWalk (in)	N/A
N/A	Any Obstructions?	N/A	N/A	Storm Grate/Utility Hazard?	N/A
	Obstruction Type			Storm Grate/Utility Type	
		N/A			N/A
			Yes	Surface Condition? (G/P)	Good

Remove & Replace Curb Ramp With Two New Directional Ramps or Equivalent.

R304.5.1, R304.2.2

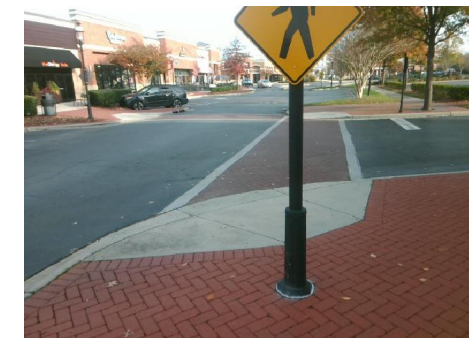
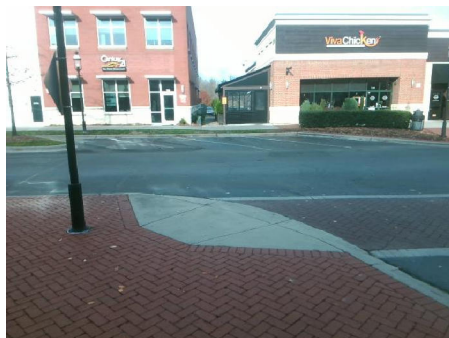
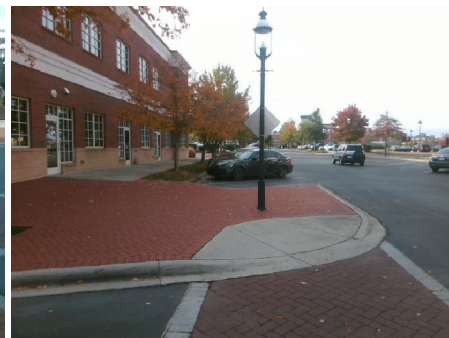
Street 1 Name **ENTRANCE**
 Stop Condition-Street 2 **StopSign**
 Street 2 Name **COPPER WY**
 Stop Condition-Street 1 **None**
