Access Compliance Report

Public Rights-of-Way

(Curb Ramps)

Intersection ID: 18759	Main Street: QUIET_BAY_CT	Cross Street: ROCK_ISLAND_RD	Location: E
ADA ID: 5E8530D9E1C4	Ramp Type: PerpDiag	Initial Pass/Fail: Fail	Overall Compliance: No
		Severity Score: 50

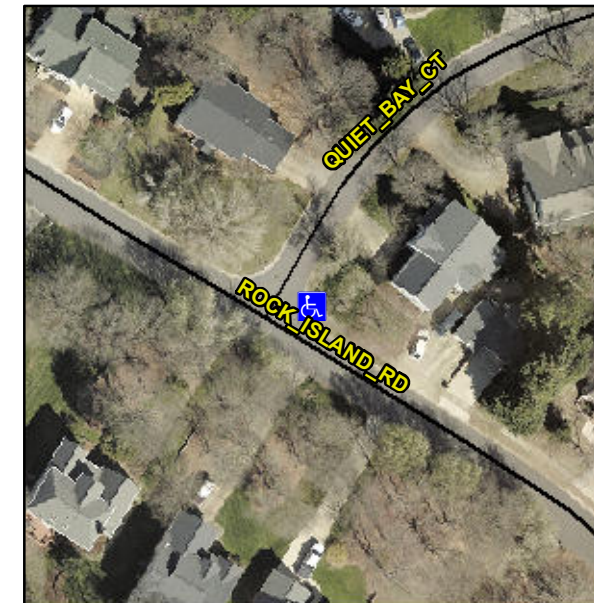
Compliance	Description	Data	Compliance	Description	Data
N/A	Ramp Length (in)	92.0	No	Ramp Slope (%)	12.8
Yes	Ramp Width (in)	48.0	No	Ramp XSlope (%)	14.9
N/A	Flare Type LT	N/A	N/A	Flare Type RT	N/A
N/A	Flare Slope LT (%)	N/A	N/A	Flare Slope RT (%)	N/A
N/A	Flare Traversable LT?	N/A	N/A	Flare Traversable RT?	N/A
N/A	Landing Length (in)	N/A	N/A	DWS Provided?	N/A
N/A	Landing Width (in)	N/A	N/A	DWS Contrast?	N/A
N/A	Landing Slope (%)	N/A	N/A	DWS Length (in)	N/A
N/A	Landing X Slope (%)	N/A	N/A	DWS Full Width?	N/A
N/A	Landing Curb? (Y/N)	N/A	N/A	DWS Offset (in)	N/A
N/A	Shared Landing?	N/A			
N/A	Gutter Ponding?	N/A	N/A	Gutter Slope (%)	N/A
N/A	Gutter Lip Ht (in)	N/A	N/A	Gutter X Slope (%)	N/A
N/A	Painted X Walk1?	No	N/A	Painted X Walk2?	No
	X Walk 1 Direction	To NW		X Walk 2 Direction	To SW
N/A	X Walk 1 Width (in)	N/A	N/A	X Walk 2 Width (in)	N/A
	X Walk 1 Slope (%)	2.5		X Walk 2 Slope (%)	7.4
	X Walk 1 X Slope (%)	9.6		X Walk 2 X Slope (%)	9.5

N/A	Ramp inside XWalk1?	N/A	N/A	Ramp inside XWalk2?	N/A
	Road Slope (%)	11.5	N/A	Clear Space?	N/A
	Road X Slope (%)	3.3	N/A	Clear Space to XWalk (in)	N/A
N/A	Any Obstructions?	N/A	N/A	Storm Grate/Utility Hazard?	N/A
	Obstruction Type			Storm Grate/Utility Type	
		N/A			N/A
			Yes	Surface Condition? (G/P)	Good

Remove & Replace Curb Ramp With Two New Directional Ramps or Equivalent.
