Access Compliance Report

Public Rights-of-Way

(Curb Ramps)

Intersection ID: N/A	Main Street: BEREWICK_TOWN_CENTRE	Cross Street: N/A	Location: NE
ADA ID: 5E89A598D28D	Ramp Type: Perp	Initial Pass/Fail: Pass	Overall Compliance: No
Severity Score: 0			
Codes/Mitigation Info/Possible Solution		Field Measurements/Component Compliance

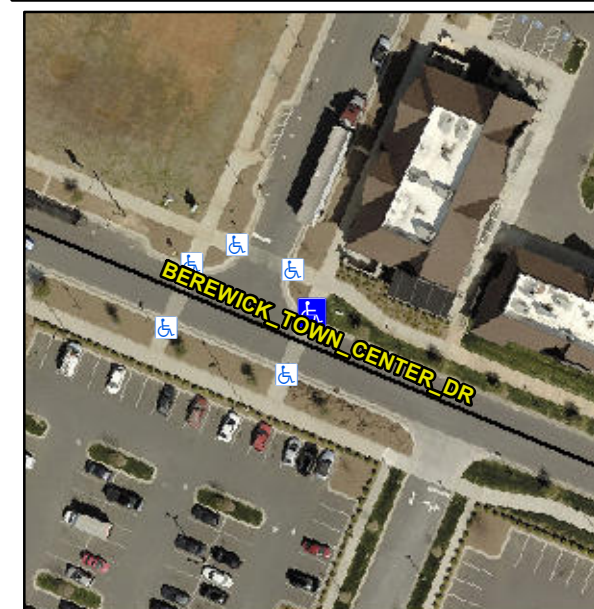
Not Found, R305.2

Compliance	Description	Data	Compliance	Description	Data
N/A	Ramp Length (in)	181.0	Yes	Ramp Slope (%)	5.2
Yes	Ramp Width (in)	93.0	Yes	Ramp XSlope (%)	0.2
Yes	Flare Type L	Curbed_NoWalkSurface	Yes	Flare Type RT	N/A
Yes	Flare Slope LT (%)	N/A	N/A	Flare Slope RT (%)	N/A
N/A	Flare Traversable LT?	No	N/A	Flare Traversable RT?	No
Yes	Landing Length (in)	100.0	Yes	DWS Provided?	Yes
Yes	Landing Width (in)	93.0	Yes	DWS Contrast?	Yes
Yes	Landing Slope (%)	1.6	Yes	DWS Length (in)	24.0
Yes	Landing X Slope (%)	1.0	Yes	DWS Full Width?	Yes
N/A	Landing Curb? (Y/N)	No	No	DWS Offset (in)	4.0
N/A	Shared Landing?	Yes			
Yes	Gutter Ponding?	No	Yes	Gutter Slope (%)	0.1
Yes	Gutter Lip Ht (in)	0.0	Yes	Gutter X Slope (%)	0.7
N/A	Painted X Walk1?	Yes	N/A	Painted X Walk2?	N/A
	X Walk 1 Direction	To SW		X Walk 2 Direction	N/A
N/A	X Walk 1 Width (in)	97.5	N/A	X Walk 2 Width (in)	N/A
	X Walk 1 Slope (%)	2.0		X Walk 2 Slope (%)	N/A
	X Walk 1 X Slope (%)	1.9		X Walk 2 X Slope (%)	N/A

Yes	Ramp inside XWalk1?	Yes	N/A	Ramp inside XWalk2?	N/A
	Road Slope (%)	N/A	N/A	Clear Space?	Yes
	Road X Slope (%)	N/A	N/A	Clear Space to XWalk (in)	N/A
Yes	Any Obstructions?	No	Yes	Storm Grate/Utility Hazard?	No
	Obstruction Type			Storm Grate/Utility Type	
		N/A			N/A
			Yes	Surface Condition? (G/P)	Good

Possible Solutions:

Remove & Replace Entire Ramp.

Total Cost: \$ 1850.00

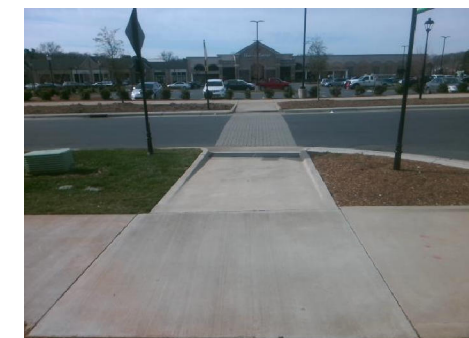
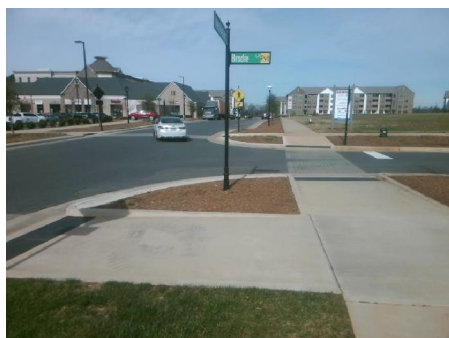
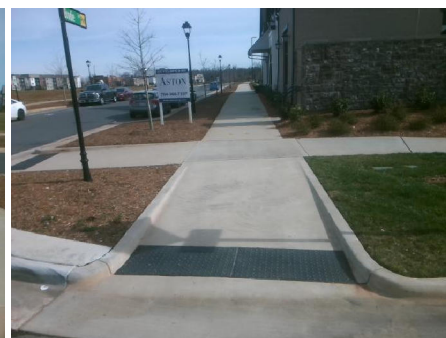
Street 1 Name **BEREWICK TOWN CENTRE**

Stop Condition-Street 2 **None**
