Access Compliance Report

Public Rights-of-Way

(Curb Ramps)

Intersection ID: 10608	Main Street: N_DAVIDSON_ST	Cross Street: JORDAN_PL	Location: NE
ADA ID: 5E9B0CA49E49	Ramp Type: Perp	Initial Pass/Fail: Fail	Overall Compliance: No
Codes/Mitigation Info/Possible Solution		Field Measurements/Component Compliance	
Severity Score: 8.75

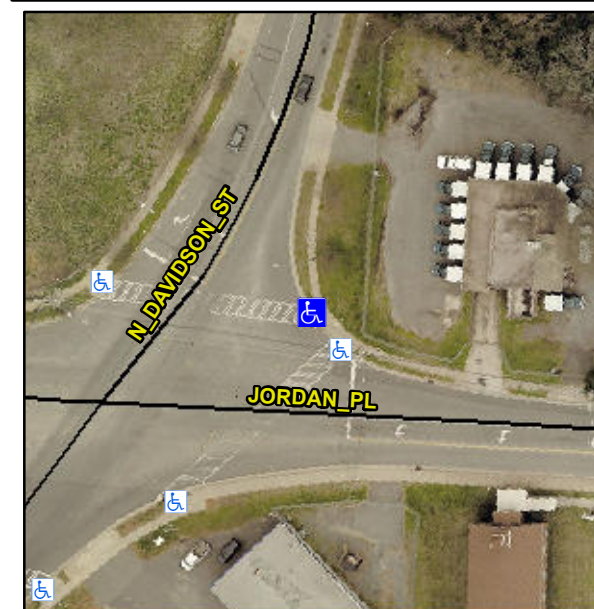
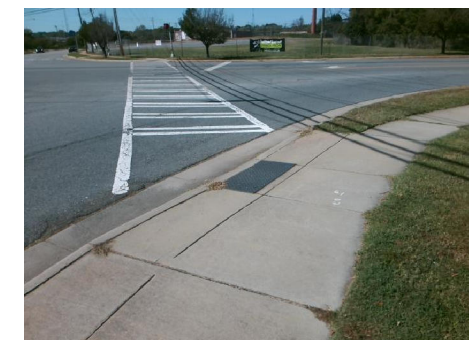
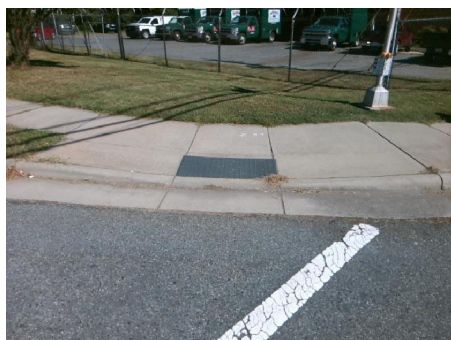
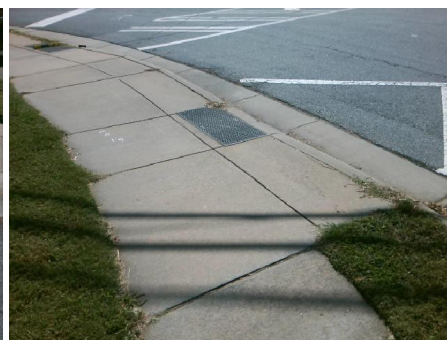
Not Found, R304.5.1

Compliance	Description	Data	Compliance	Description	Data
N/A	Ramp Length (in)	83.0	Yes	Ramp Slope (%)	6.1
No	Ramp Width (in)	44.0	Yes	Ramp XSlope (%)	0.7
N/A	Flare Type LT	N/A	N/A	Flare Type RT	N/A
N/A	Flare Slope LT (%)	N/A	N/A	Flare Slope RT (%)	N/A
N/A	Flare Traversable LT?	N/A	N/A	Flare Traversable RT?	N/A
N/A	Landing Length (in)	N/A	N/A	DWS Provided?	N/A
N/A	Landing Width (in)	N/A	N/A	DWS Contrast?	N/A
N/A	Landing Slope (%)	N/A	N/A	DWS Length (in)	N/A
N/A	Landing X Slope (%)	N/A	N/A	DWS Full Width?	N/A
N/A	Landing Curb? (Y/N)	N/A	N/A	DWS Offset (in)	N/A
N/A	Shared Landing?	N/A			
N/A	Gutter Ponding?	N/A	N/A	Gutter Slope (%)	N/A
N/A	Gutter Lip Ht (in)	N/A	N/A	Gutter X Slope (%)	N/A
N/A	Painted X Walk1?	Yes	N/A	Painted X Walk2?	N/A
	X Walk 1 Direction	To NW		X Walk 2 Direction	N/A
N/A	X Walk 1 Width (in)	104.5	N/A	X Walk 2 Width (in)	N/A
	X Walk 1 Slope (%)	1.1		X Walk 2 Slope (%)	N/A
	X Walk 1 X Slope (%)	1.6		X Walk 2 X Slope (%)	N/A

N/A	Ramp inside XWalk1?	Yes	N/A	Ramp inside XWalk2?	N/A
	Road Slope (%)	N/A	N/A	Clear Space?	N/A
	Road X Slope (%)	N/A	N/A	Clear Space to XWalk (in)	N/A
N/A	Any Obstructions?	N/A	N/A	Storm Grate/Utility Hazard?	N/A
	Obstruction Type			Storm Grate/Utility Type	
		N/A			N/A
		Yes		Surface Condition? (G/P)	Good

Remove & Replace Entire Ramp.

Total Cost: \$ 1850.00
