Access Compliance Report

Public Rights-of-Way

(Curb Ramps)

Intersection ID: 50632	Main Street: CORAL_ROSE_RD	Cross Street: RED_WATER_RD	Location: SE
ADA ID: 5E9E5C963BF3	Ramp Type: Perp	Initial Pass/Fail: Fail	Overall Compliance: No
Severity Score: 21.25			
Codes/Mitigation Info/Possible Solution		Field Measurements/Component Compliance

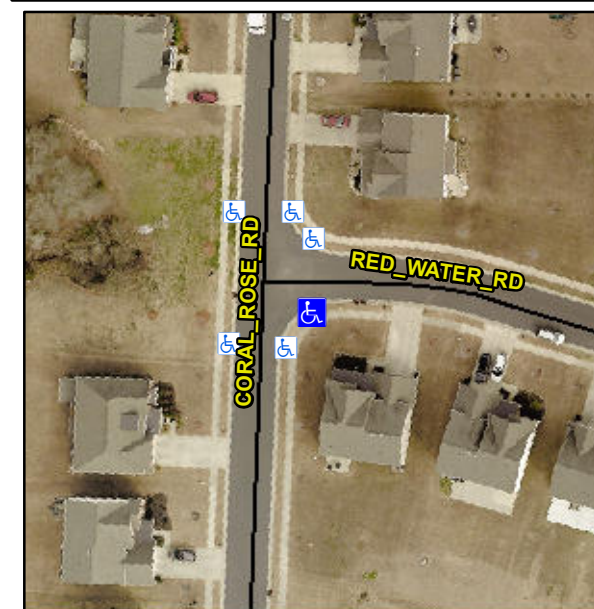
PROW/ADA:

Not Found, R304.5.1, R304.2.2

Compliance	Description	Data	Compliance	Description	Data
N/A	Ramp Length (in)	46.0	No	Ramp Slope (%)	10.0
No	Ramp Width (in)	47.0	Yes	Ramp XSlope (%)	1.0
N/A	Flare Type LT	N/A	N/A	Flare Type RT	N/A
N/A	Flare Slope LT (%)	N/A	N/A	Flare Slope RT (%)	N/A
N/A	Flare Traversable LT?	N/A	N/A	Flare Traversable RT?	N/A
N/A	Landing Length (in)	N/A	N/A	DWS Provided?	N/A
N/A	Landing Width (in)	N/A	N/A	DWS Contrast?	N/A
N/A	Landing Slope (%)	N/A	N/A	DWS Length (in)	N/A
N/A	Landing X Slope (%)	N/A	N/A	DWS Full Width?	N/A
N/A	Landing Curb? (Y/N)	N/A	N/A	DWS Offset (in)	N/A
N/A	Shared Landing?	N/A			
N/A	Gutter Ponding?	N/A	N/A	Gutter Slope (%)	N/A
N/A	Gutter Lip Ht (in)	N/A	N/A	Gutter X Slope (%)	N/A
N/A	Painted X Walk1?	No	N/A	Painted X Walk2?	N/A
	X Walk 1 Direction	To N		X Walk 2 Direction	N/A
N/A	X Walk 1 Width (in)	N/A	N/A	X Walk 2 Width (in)	N/A
	X Walk 1 Slope (%)	0.6		X Walk 2 Slope (%)	N/A
	X Walk 1 X Slope (%)	0.4		X Walk 2 X Slope (%)	N/A

N/A	Ramp inside XWalk1?	N/A	N/A	Ramp inside XWalk2?	N/A
	Road Slope (%)	N/A	N/A	Clear Space?	N/A
	Road X Slope (%)	N/A	N/A	Clear Space to XWalk (in)	N/A
N/A	Any Obstructions?	N/A	N/A	Storm Grate/Utility Hazard?	N/A
	Obstruction Type			Storm Grate/Utility Type	
		N/A			N/A
			Yes	Surface Condition? (G/P)	Good

Possible Solutions:

Remove & Replace Entire Ramp.
