Access Compliance Report

Public Rights-of-Way

(Curb Ramps)

Intersection ID: 44347	Main Street: CHOATE_CR	Cross Street: STONE_ARBOR_WY	Location: NE
ADA ID: 5EA4678FF178	Ramp Type: PerpDiag	Initial Pass/Fail: Fail	Overall Compliance: No
Severity Score: 25			
Codes/Mitigation Info/Possible Solution		Field Measurements/Component Compliance

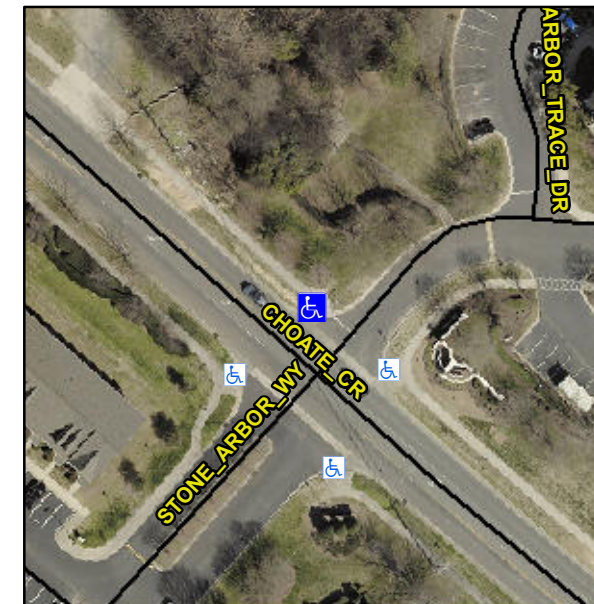
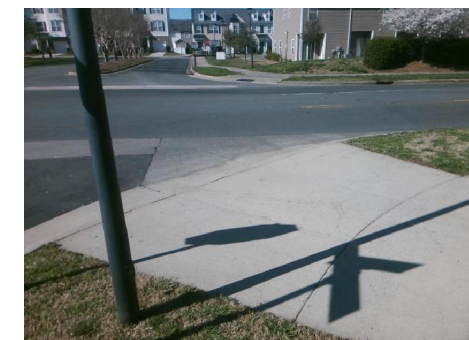
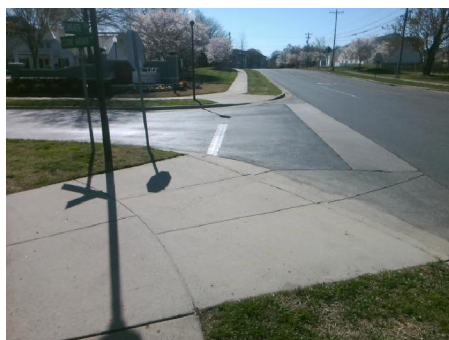
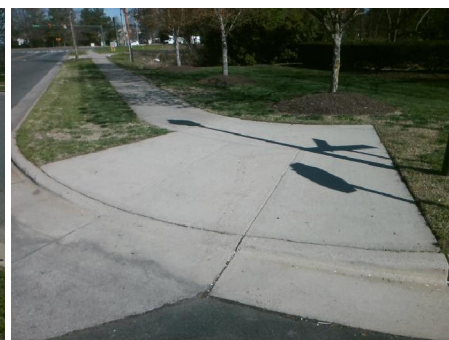
Compliance	Description	Data	Compliance	Description	Data
N/A	Ramp Length (in)	96.0	No	Ramp Slope (%)	12.0
Yes	Ramp Width (in)	49.0	Yes	Ramp XSlope (%)	0.3
N/A	Flare Type LT	N/A	N/A	Flare Type RT	N/A
N/A	Flare Slope LT (%)	N/A	N/A	Flare Slope RT (%)	N/A
N/A	Flare Traversable LT?	N/A	N/A	Flare Traversable RT?	N/A
N/A	Landing Length (in)	N/A	N/A	DWS Provided?	N/A
N/A	Landing Width (in)	N/A	N/A	DWS Contrast?	N/A
N/A	Landing Slope (%)	N/A	N/A	DWS Length (in)	N/A
N/A	Landing X Slope (%)	N/A	N/A	DWS Full Width?	N/A
N/A	Landing Curb? (Y/N)	N/A	N/A	DWS Offset (in)	N/A
N/A	Shared Landing?	N/A			
N/A	Gutter Ponding?	N/A	N/A	Gutter Slope (%)	N/A
N/A	Gutter Lip Ht (in)	N/A	N/A	Gutter X Slope (%)	N/A
N/A	Painted X Walk1?	No	N/A	Painted X Walk2?	No
	X Walk 1 Direction	To SW		X Walk 2 Direction	To SE
N/A	X Walk 1 Width (in)	N/A	N/A	X Walk 2 Width (in)	N/A
	X Walk 1 Slope (%)	3.6		X Walk 2 Slope (%)	0.5
	X Walk 1 X Slope (%)	1.0		X Walk 2 X Slope (%)	0.9

N/A	Ramp inside XWalk1?	N/A	N/A	Ramp inside XWalk2?	N/A
	Road Slope (%)	1.9	N/A	Clear Space?	N/A
	Road X Slope (%)	2.4	N/A	Clear Space to XWalk (in)	N/A
N/A	Any Obstructions?	N/A	N/A	Storm Grate/Utility Hazard?	N/A
	Obstruction Type			Storm Grate/Utility Type	
		N/A			N/A
			Yes	Surface Condition? (G/P)	Good

Possible Solutions:

Remove & Replace Curb Ramp With Two New Directional Ramps or Equivalent.

Not Found, R304.2.2
