Access Compliance Report

Public Rights-of-Way

(Curb Ramps)

Intersection ID: 30556	Main Street: GREEN_LEA_CT	Cross Street: GREENCREEK_DR	Location: W
ADA ID: 5EB54A79B69C	Ramp Type: PerpDiag	Initial Pass/Fail: Fail	Overall Compliance: No
Severity Score: 12.5			
Codes/Mitigation Info/Possible Solution		Field Measurements/Component Compliance

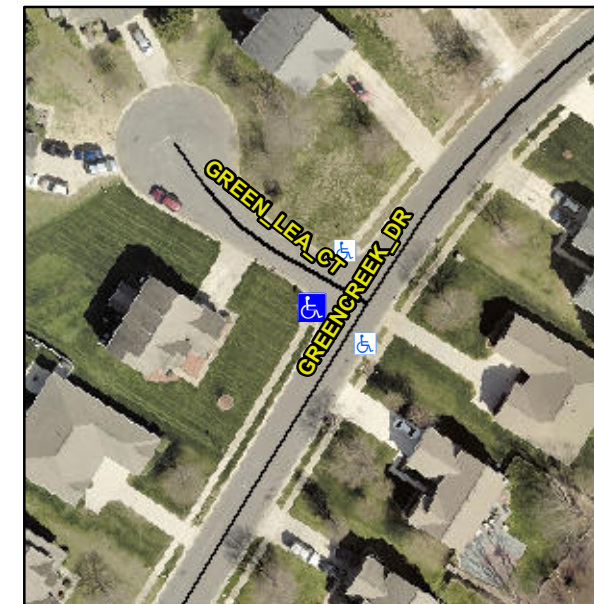
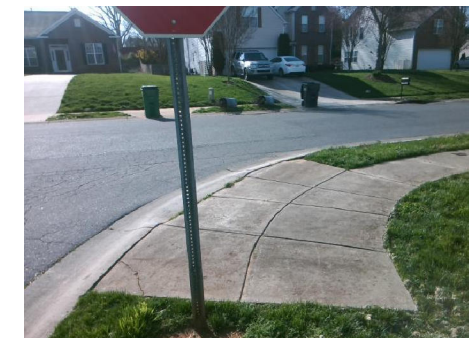
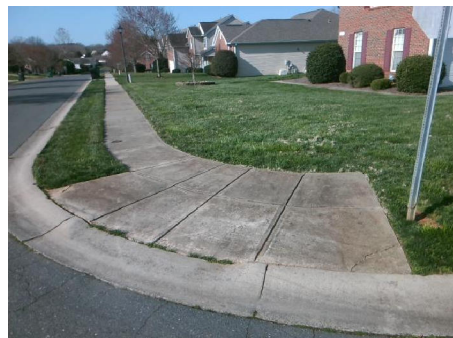
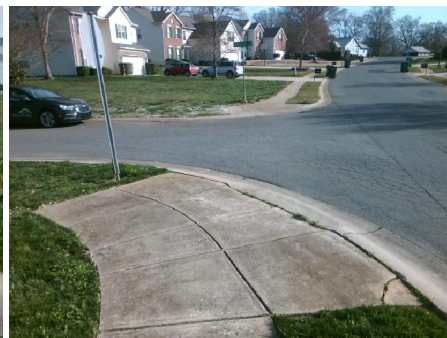
Compliance	Description	Data	Compliance	Description	Data
N/A	Ramp Length (in)	48.0	No	Ramp Slope (%)	8.9
Yes	Ramp Width (in)	48.0	Yes	Ramp XSlope (%)	1.5
N/A	Flare Type LT	N/A	N/A	Flare Type RT	N/A
N/A	Flare Slope LT (%)	N/A	N/A	Flare Slope RT (%)	N/A
N/A	Flare Traversable LT?	N/A	N/A	Flare Traversable RT?	N/A
N/A	Landing Length (in)	N/A	N/A	DWS Provided?	N/A
N/A	Landing Width (in)	N/A	N/A	DWS Contrast?	N/A
N/A	Landing Slope (%)	N/A	N/A	DWS Length (in)	N/A
N/A	Landing X Slope (%)	N/A	N/A	DWS Full Width?	N/A
N/A	Landing Curb? (Y/N)	N/A	N/A	DWS Offset (in)	N/A
N/A	Shared Landing?	N/A			
N/A	Gutter Ponding?	N/A	N/A	Gutter Slope (%)	N/A
N/A	Gutter Lip Ht (in)	N/A	N/A	Gutter X Slope (%)	N/A
N/A	Painted X Walk1?	No	N/A	Painted X Walk2?	No
	X Walk 1 Direction	To SE		X Walk 2 Direction	To NE
N/A	X Walk 1 Width (in)	N/A	N/A	X Walk 2 Width (in)	N/A
	X Walk 1 Slope (%)	2.6		X Walk 2 Slope (%)	1.2
	X Walk 1 X Slope (%)	2.4		X Walk 2 X Slope (%)	1.9

N/A	Ramp inside XWalk1?	N/A	N/A	Ramp inside XWalk2?	N/A
	Road Slope (%)	1.4	N/A	Clear Space?	N/A
	Road X Slope (%)	6.1	N/A	Clear Space to XWalk (in)	N/A
N/A	Any Obstructions?	N/A	N/A	Storm Grate/Utility Hazard?	N/A
	Obstruction Type			Storm Grate/Utility Type	
		N/A			N/A
			Yes	Surface Condition? (G/P)	Good

Remove & Replace Curb Ramp With Two New Directional Ramps or Equivalent.

R304.2.2

\$ 3200.00
