Access Compliance Report Public Rights-of-Way (Curb Ramps)

Intersection ID: 11313Main Street:STAFFORD_DRCross Street:WILKINSON_BVLocation:NEADA ID: 5EB94332E5A6Ramp Type:IslandPerpInitial Pass/Fail:FailOverall Compliance:NoSeverity Score:8.75

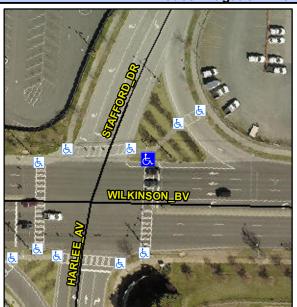
Field Measurements/Component Compliance								
Compl	iance Description	Data	Comp	liance	Description	Data		
N/A	Ramp Length (in)	85.0	Yes	Ramp	Slope (%)	5.6		
No	Ramp Width (in)	47.0	Yes	Ramp	XSlope (%)	0.1		
N/A	Flare Type LT	N/A	N/A	Flare	Type RT	N/A		
N/A	Flare Slope LT (%)	N/A	N/A	Flare	Slope RT (%)	N/A		
N/A	Flare Traversable LT?	N/A	N/A	Flare	Traversable RT?	N/A		
N/A	Landing Length (in)	N/A	N/A	DWS	Provided?	N/A		
N/A	Landing Width (in)	N/A	N/A	DWS	Contrast?	N/A		
N/A	Landing Slope (%)	N/A	N/A	DWS	Length (in)	N/A		
N/A	Landing X Slope (%)	N/A	N/A	DWS	Full Width?	N/A		
N/A	Landing Curb? (Y/N)	N/A	N/A	DWS	Offset (in)	N/A		
N/A	Shared Landing?	N/A						
N/A	Gutter Ponding?	N/A	N/A	Gutte	r Slope (%)	N/A		
N/A	Gutter Lip Ht (in)	N/A	N/A	Gutte	er X Slope (%)	N/A		
N/A	Painted X Walk1?	Yes	N/A	Paint	ed X Walk2?	N/A		
	X Walk 1 Direction	To S		X Wa	lk 2 Direction	N/A		
N/A	X Walk 1 Width (in)	108.0	N/A	X Wa	lk 2 Width (in)	N/A

X Walk 1 Slope (%)	2.3		X Wa	lk 2 Slope (%)	N/A		
	X Walk 1 X Slope (%)	0.1		X Wa	lk 2 X Slope (%)	N/A		
N/A	Ramp inside XWalk1?	Yes	N/A	Ram	inside XWalk2?	N/A		
	Road Slope (%)	N/A	N/A	Clear	Space?	N/A		
	Road X Slope (%)	N/A	N/A	Clear	Space to XWalk (in)	N/A		
N/A	Any Obstructions?	N/A	N/A	Storn	n Grate/Utility Hazard?	N/A		
	Obstruction Type			Storn	n Grate/Utility Type			
		N/A				N/A		
			Yes	Surfa	ce Condition? (G/P)	Good

ossible Solution	
ossible Solutions:	Comp
Remove & Replace Entire Ramp.	N/A
	No
	N/A
	N/A
	N/A
	N/A
urveyor Notes:	N/A
N/A	N/A
	N/A
	N/A
	N/A
ROW/ADA:	N/A
Not Found, R304.5.1	N/A
	N/A
	N/A
	N/A
