Access Compliance Report

Public Rights-of-Way

(Curb Ramps)

| Intersection ID: 26629 | Main Street: ALPINE_FOREST_CT | Cross Street: MANOR_HOUSE_DR | Location: SW |

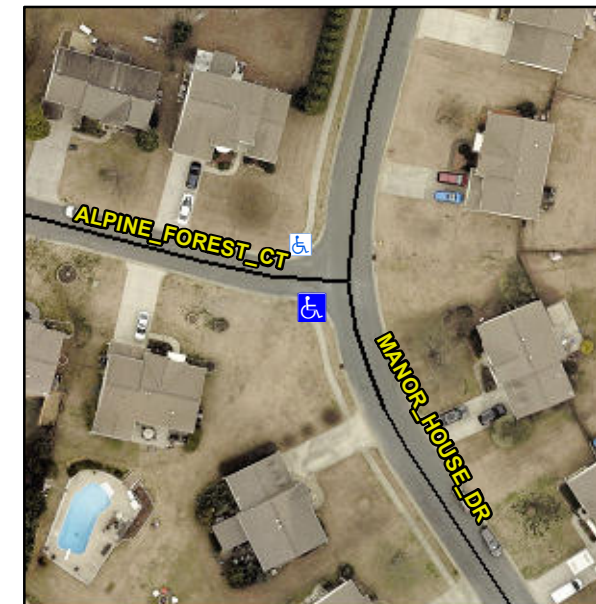
| ADA ID: 5EBB2C34D531 | Ramp Type: BlendTrans1 | Initial Pass/Fail: Fail | Overall Compliance: No |
| Severity Score: 1.25 | | | |

Not Found, R304.5.3

| Compliance | Description | Data | Compliance | Description | Data |
|---|---|---|---|---|---|
| Yes | Ramp Width (in) | 48.0 | No | BlendTrans XSlope (%) | 3.0 |
| | | | No | Curb Slope (%) | 14.6 |

Remove & Replace Curb Ramp With Two New Directional Ramps or Equivalent.

Total Cost: \$ 3200.00
