Access Compliance Report

Public Rights-of-Way

(Curb Ramps)

Intersection ID: 8285	Main Street: CATHERINE_SIMMONS_AV	Cross Street: HAINES_ST	Location:	NW
ADA ID: 5EBD57DC21A9	Ramp Type: Perp	Initial Pass/Fail: Fail	Overall Compliance: No	Severity Score: 47.5

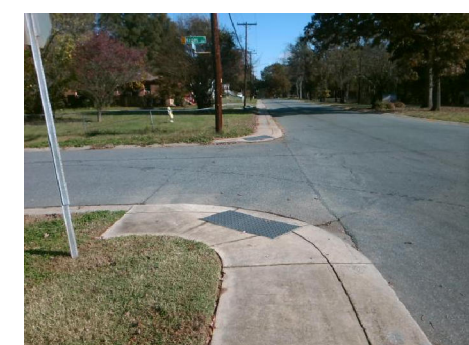
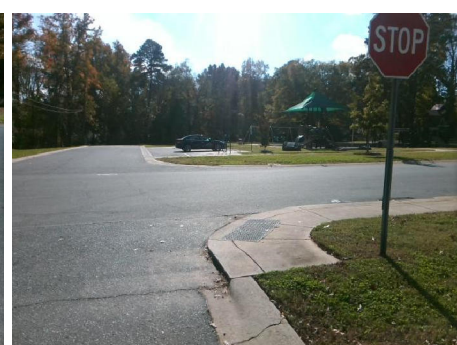
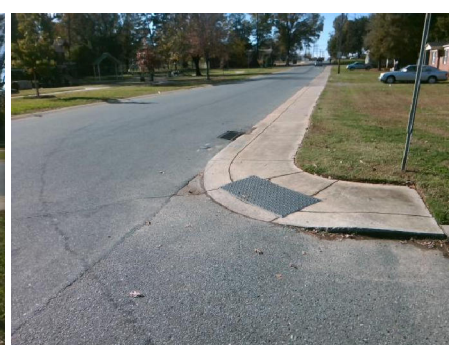
Possible Solutions:		Compliance	Description	Data	Compliance	Description	Data
	Remove & Replace Entire Ramp.		N/A	Ramp Length (in)	40.0	No	Ramp Slope (%)	8.7
			No	Ramp Width (in)	22.5	Yes	Ramp XSlope (%)	1.5
			N/A	Flare Type LT	N/A	N/A	Flare Type RT	N/A
			N/A	Flare Slope LT (%)	N/A	N/A	Flare Slope RT (%)	N/A
			N/A	Flare Traversable LT?	N/A	N/A	Flare Traversable RT?	N/A
			N/A	Landing Length (in)	N/A	N/A	DWS Provided?	N/A
			N/A	Landing Width (in)	N/A	N/A	DWS Contrast?	N/A
			N/A	Landing Slope (%)	N/A	N/A	DWS Length (in)	N/A
			N/A	Landing X Slope (%)	N/A	N/A	DWS Full Width?	N/A
<p>Surveyor Notes:</p> <p>N/A</p> <p>PROW/ADA:</p> <p>R304.5.1, R304.2.2</p>			N/A	Landing Curb? (Y/N)	N/A	N/A	DWS Offset (in)	N/A
			N/A	Shared Landing?	N/A			
			N/A	Gutter Ponding?	N/A	N/A	Gutter Slope (%)	N/A
			N/A	Gutter Lip Ht (in)	N/A	N/A	Gutter X Slope (%)	N/A

N/A	Painted X Walk1?	No	N/A	Painted X Walk2?	N/A
				X Walk 1 Direction	To E		X Walk 2 Direction	N/A
			N/A	X Walk 1 Width (in)	N/A	N/A	X Walk 2 Width (in)	N/A
				X Walk 1 Slope (%)	2.0		X Walk 2 Slope (%)	N/A
				X Walk 1 X Slope (%)	0.2		X Walk 2 X Slope (%)	N/A
			N/A	Ramp inside XWalk1?	N/A	N/A	Ramp inside XWalk2?	N/A
			Road Slope (%)	N/A	N/A	Clear Space?	N/A	
			Road X Slope (%)	N/A	N/A	Clear Space to XWalk (in)	N/A	
		N/A	Any Obstructions?	N/A	N/A	Storm Grate/Utility Hazard?	N/A	
			Obstruction Type			Storm Grate/Utility Type		
					N/A		N/A	
						Yes	Surface Condition? (G/P)	Good
Total Cost:		\$ 1850.00
