# Access Compliance Report

## Public Rights-of-Way

### (Curb Ramps)

Intersection ID: 45504	Main Street: FIRST_BLOOM_RD	Cross Street: MEADOW_BOTTOM_RD	Location: E
ADA ID: 5EC1AA7E26F2	Ramp Type: PerpDiag	Initial Pass/Fail: Fail	Overall Compliance: No
Severity Score: 47.5			
Codes/Mitigation Info/Possible Solution		Field Measurements/Component Compliance

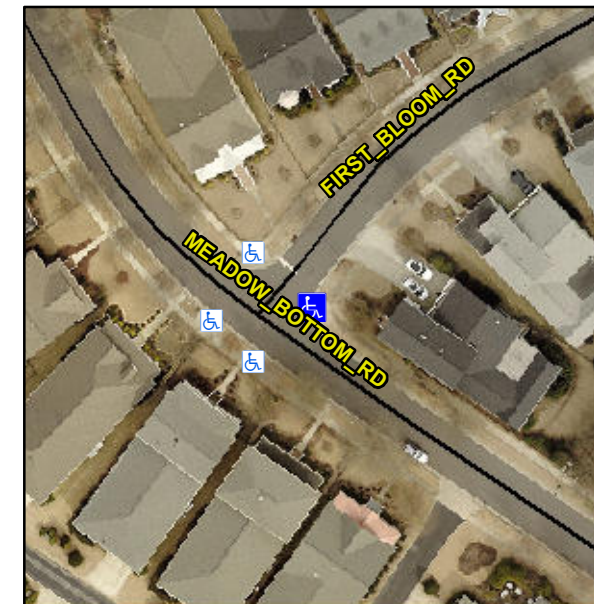
**Not Found, R304.5.1, R304.5.3**

Compliance	Description	Data	Compliance	Description	Data
N/A	Ramp Length (in)	72.0	Yes	Ramp Slope (%)	7.9
No	Ramp Width (in)	30.0	No	Ramp XSlope (%)	5.2
N/A	Flare Type LT	N/A	N/A	Flare Type RT	N/A
N/A	Flare Slope LT (%)	N/A	N/A	Flare Slope RT (%)	N/A
N/A	Flare Traversable LT?	N/A	N/A	Flare Traversable RT?	N/A
N/A	Landing Length (in)	N/A	N/A	DWS Provided?	N/A
N/A	Landing Width (in)	N/A	N/A	DWS Contrast?	N/A
N/A	Landing Slope (%)	N/A	N/A	DWS Length (in)	N/A
N/A	Landing X Slope (%)	N/A	N/A	DWS Full Width?	N/A
N/A	Landing Curb? (Y/N)	N/A	N/A	DWS Offset (in)	N/A
N/A	Shared Landing?	N/A			
N/A	Gutter Ponding?	N/A	N/A	Gutter Slope (%)	N/A
N/A	Gutter Lip Ht (in)	N/A	N/A	Gutter X Slope (%)	N/A
N/A	Painted X Walk1?	No	N/A	Painted X Walk2?	No
	X Walk 1 Direction	To NW		X Walk 2 Direction	To SW
N/A	X Walk 1 Width (in)	N/A	N/A	X Walk 2 Width (in)	N/A
	X Walk 1 Slope (%)	3.9		X Walk 2 Slope (%)	0.3
	X Walk 1 X Slope (%)	0.6		X Walk 2 X Slope (%)	3.4

N/A	Ramp inside XWalk1?	N/A	N/A	Ramp inside XWalk2?	N/A
	Road Slope (%)	1.5	N/A	Clear Space?	N/A
	Road X Slope (%)	3.3	N/A	Clear Space to XWalk (in)	N/A
N/A	Any Obstructions?	N/A	N/A	Storm Grate/Utility Hazard?	N/A
	Obstruction Type			Storm Grate/Utility Type	
		N/A			N/A
		Yes		Surface Condition? (G/P)	Good

**Remove & Replace Curb Ramp With Two New Directional Ramps or Equivalent.**

Total Cost: \$ 3200.00
