Access Compliance Report

Public Rights-of-Way

(Curb Ramps)

Intersection ID: 7127	Main Street: CUPPED_OAK_CT	Cross Street: LOVE_RIDGE_LN	Location: NW
ADA ID: 5EC246DD9F98	Ramp Type: Directional1	Initial Pass/Fail: Fail	Overall Compliance: No
			Severity Score: 33.75

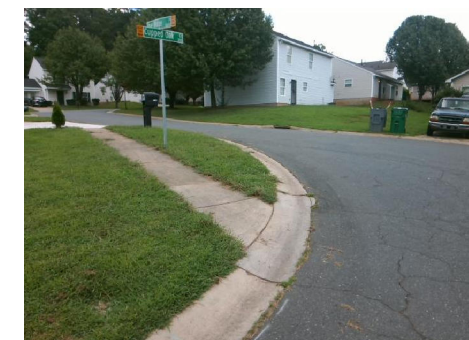
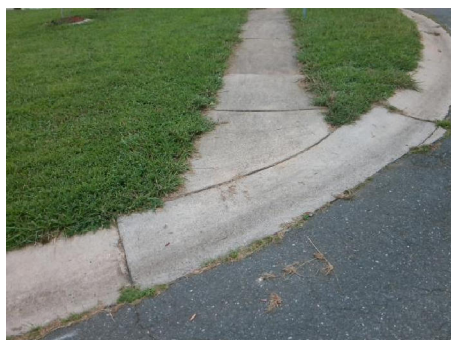
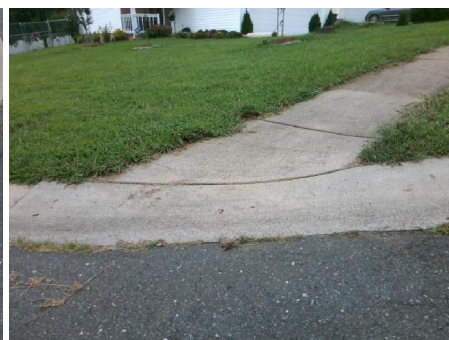
Possible Solutions:		Compliance	Description	Data	Compliance	Description	Data
	Remove & Replace Entire Ramp.		N/A	Ramp Length (in)	18.0	N/A	Grade Break?	N/A
			No	Ramp Width (in)	47.0	N/A	Grade Break Slope (%)	0.0
			No	Ramp Slope (%)	16.8	N/A	Grade Break XSlope (%)	0.0
			Yes	Ramp XSlope (%)	1.4			
			N/A	Flare Type LT	N/A	N/A	Flare Type RT	N/A
			N/A	Flare Slope LT (%)	N/A	N/A	Flare Slope RT (%)	0.0
			N/A	Flare Traversable LT?	N/A	N/A	Flare Traversable RT?	N/A
			N/A	Landing Length (in)	0.0	N/A	DWS Provided?	N/A
			N/A	Landing Width (in)	0.0	N/A	DWS Contrast?	N/A
Surveyor Notes:			N/A	Landing Slope (%)	0.0	N/A	DWS Length (in)	N/A
N/A			N/A	Landing X Slope (%)	0.0	N/A	DWS Full Width?	N/A
PROW/ADA:			N/A	Landing Curb? (Y/N)	N/A	N/A	DWS Offset LT (in)	N/A
R304.5.1, R304.2.2			N/A	Shared Landing?	N/A	N/A	DWS Offset RT (in)	N/A

N/A	Gutter Ponding?	0.0	N/A	Gutter Slope (%)	N/A
			N/A	Gutter Lip Ht (in)	0.0	N/A	Gutter X Slope (%)	N/A
			N/A	Painted X Walk1?	No		Road Slope (%)	3.2
				X Walk 1 Direction	To S		Road X Slope (%)	6.6
				X Walk 1 Width (in)	N/A		Clear Space?	N/A
				X Walk 1 Slope (%)	3.2	N/A	Clear Space to XWalk (in)	N/A
				X Walk 1 X Slope (%)	6.6	N/A	Storm Grate/Utility Hazard?	N/A
			N/A	Ramp inside XWalk1?	N/A		Storm Grate/Utility Type	N/A
			N/A	Any Obstructions?	N/A			N/A
				Obstruction Type		Yes	Surface Condition? (G/P)	Good
					N/A	N/A	Curb Slope (%)	28.4
Total Cost:		\$	1600.00
