Access Compliance Report Public Rights-of-Way (Curb Ramps)

Intersection ID: 10041624 Main Street: WHITEHALL EXECUTIVE CENTERS SDStreet: N/A Location: SW

ADA ID: 5EC970DE8776 Ramp Type: PerpDiag Initial Pass/Fail: Fail **Overall Compliance: No** Severity Score: 13.75

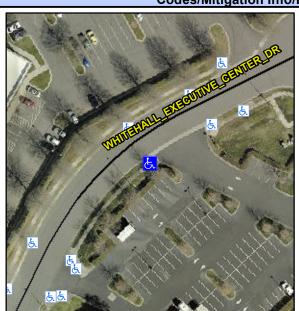
Comp	pliance Description	Data	Comp	liance Description	Data
N/A	Ramp Length (in)	47.0	No	Ramp Slope (%)	9.0
Yes	Ramp Width (in)	48.0	No	Ramp XSlope (%)	2.1
N/A	Flare Type LT	N/A	N/A	Flare Type RT	N/A
N/A	Flare Slope LT (%)	N/A	N/A	Flare Slope RT (%)	N/A
N/A	Flare Traversable LT?	N/A	N/A	Flare Traversable RT?	N/A
N/A	Landing Length (in)	N/A	N/A	DWS Provided?	N/A
N/A	Landing Width (in)	N/A	N/A	DWS Contrast?	N/A
N/A	Landing Slope (%)	N/A	N/A	DWS Length (in)	N/A
N/A	Landing X Slope (%)	N/A	N/A	DWS Full Width?	N/A
N/A	Landing Curb? (Y/N)	N/A	N/A	DWS Offset (in)	N/A
N/A	Shared Landing?	N/A			
N/A	Gutter Ponding?	N/A	N/A	Gutter Slope (%)	N/A
N/A	Gutter Lip Ht (in)	N/A	N/A	Gutter X Slope (%)	N/A
N/A	Painted X Walk1?	No	N/A	Painted X Walk2?	No
	X Walk 1 Direction	To N		X Walk 2 Direction	To E
N/A	X Walk 1 Width (in)	N/A	N/A	X Walk 2 Width (in)	N/A
	X Walk 1 Slope (%)	2.2		X Walk 2 Slope (%)	3.7
	X Walk 1 X Slope (%)	10.1		X Walk 2 X Slope (%)	2.6

N/A	Ramp inside XWalk1?	N/A	N/A	Ramp inside XWalk2?	N/A
	Road Slope (%)	2.9	N/A	Clear Space?	N/A
	Road X Slope (%)	9.6	N/A	Clear Space to XWalk (in)	N/A
N/A	Any Obstructions?	N/A	N/A	Storm Grate/Utility Hazard?	N/A
	Obstruction Type			Storm Grate/Utility Type	
		N/A			N/A
			Yes	Surface Condition? (G/P)	Good

Possible Solutions: **Remove & Replace Curb Ramp With Two New Directional Ramps or** Equivalent. Surveyor N/A PROW/AD
