# Access Compliance Report

## Public Rights-of-Way

### (Curb Ramps)

Intersection ID: N/A	Main Street: YORK_CENTER	Cross Street: N/A	Location: SW
ADA ID: 5EF2D7290A36	Ramp Type: Directional1	Initial Pass/Fail: Fail	Overall Compliance: No
Codes/Mitigation Info/Possible Solution		Field Measurements/Component Compliance	
Severity Score: 12.5

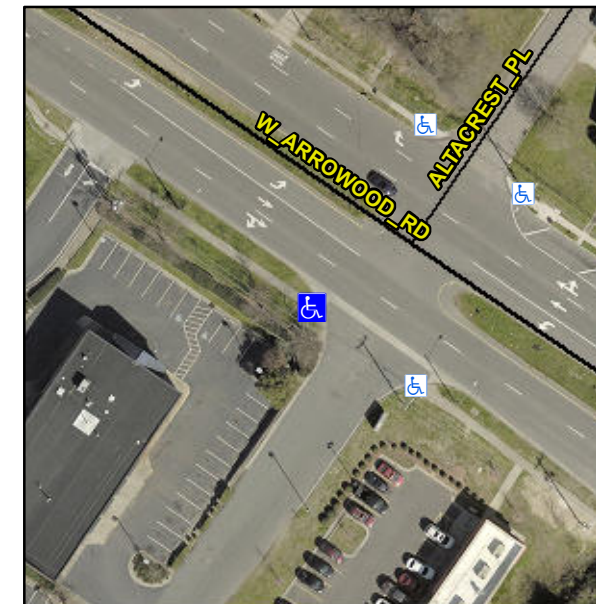
**R304.2.2**

Compliance	Description	Data	Compliance	Description	Data
N/A	Ramp Length (in)	53.0	N/A	Grade Break?	N/A
Yes	Ramp Width (in)	49.0	N/A	Grade Break Slope (%)	0.0
No	Ramp Slope (%)	8.4	N/A	Grade Break XSlope (%)	0.0
Yes	Ramp XSlope (%)	2.0			
N/A	Flare Type LT	N/A	N/A	Flare Type RT	N/A
N/A	Flare Slope LT (%)	N/A	N/A	Flare Slope RT (%)	0.0
N/A	Flare Traversable LT?	N/A	N/A	Flare Traversable RT?	N/A
N/A	Landing Length (in)	0.0	N/A	DWS Provided?	N/A
N/A	Landing Width (in)	0.0	N/A	DWS Contrast?	N/A
N/A	Landing Slope (%)	0.0	N/A	DWS Length (in)	N/A
N/A	Landing X Slope (%)	0.0	N/A	DWS Full Width?	N/A
N/A	Landing Curb? (Y/N)	N/A	N/A	DWS Offset LT (in)	N/A
N/A	Shared Landing?	N/A	N/A	DWS Offset RT (in)	N/A
N/A	Gutter Ponding?	0.0	N/A	Gutter Slope (%)	N/A
N/A	Gutter Lip Ht (in)	0.0	N/A	Gutter X Slope (%)	N/A
N/A	Painted X Walk1?	No		Road Slope (%)	2.9
	X Walk 1 Direction	To E		Road X Slope (%)	4.0
	X Walk 1 Width (in)	N/A		Clear Space?	N/A

X Walk 1 Slope (%)	2.9	N/A	Clear Space to XWalk (in)	N/A
	X Walk 1 X Slope (%)	4.0	N/A	Storm Grate/Utility Hazard?	N/A
N/A	Ramp inside XWalk1?	N/A		Storm Grate/Utility Type	
N/A	Any Obstructions?	N/A			N/A
	Obstruction Type		Yes	Surface Condition? (G/P)	Good
			N/A	Curb Slope (%)	2.8

**Remove & Replace Entire Ramp.**

Total Cost: \$ 1600.00
