Access Compliance Report

Public Rights-of-Way

(Curb Ramps)

Intersection ID: 18385	Main Street: MONTFORD_DR	Cross Street: PARK_RD	Location: SW
ADA ID: 5F0441C5DD73	Ramp Type: PerpDiag	Initial Pass/Fail: Fail	Overall Compliance: No
Severity Score: 12.5			
Codes/Mitigation Info/Possible Solution		Field Measurements/Component Compliance

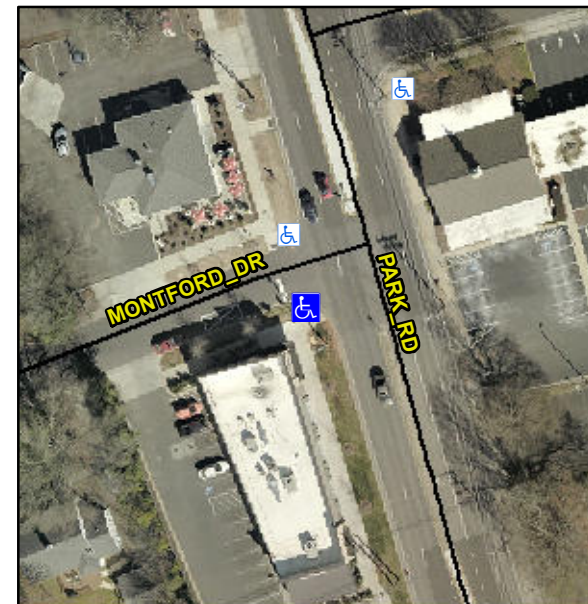
Compliance	Description	Data	Compliance	Description	Data
N/A	Ramp Length (in)	128.0	No	Ramp Slope (%)	10.0
Yes	Ramp Width (in)	49.0	Yes	Ramp XSlope (%)	0.9
N/A	Flare Type LT	N/A	N/A	Flare Type RT	N/A
N/A	Flare Slope LT (%)	N/A	N/A	Flare Slope RT (%)	N/A
N/A	Flare Traversable LT?	N/A	N/A	Flare Traversable RT?	N/A
N/A	Landing Length (in)	N/A	N/A	DWS Provided?	N/A
N/A	Landing Width (in)	N/A	N/A	DWS Contrast?	N/A
N/A	Landing Slope (%)	N/A	N/A	DWS Length (in)	N/A
N/A	Landing X Slope (%)	N/A	N/A	DWS Full Width?	N/A
N/A	Landing Curb? (Y/N)	N/A	N/A	DWS Offset (in)	N/A
N/A	Shared Landing?	N/A			
N/A	Gutter Ponding?	N/A	N/A	Gutter Slope (%)	N/A
N/A	Gutter Lip Ht (in)	N/A	N/A	Gutter X Slope (%)	N/A
N/A	Painted X Walk1?	No	N/A	Painted X Walk2?	No
	X Walk 1 Direction	To E		X Walk 2 Direction	To N
N/A	X Walk 1 Width (in)	N/A	N/A	X Walk 2 Width (in)	N/A
	X Walk 1 Slope (%)	6.5		X Walk 2 Slope (%)	1.1
	X Walk 1 X Slope (%)	0.0		X Walk 2 X Slope (%)	3.5

N/A	Ramp inside XWalk1?	N/A	N/A	Ramp inside XWalk2?	N/A
	Road Slope (%)	2.0	N/A	Clear Space?	N/A
	Road X Slope (%)	4.4	N/A	Clear Space to XWalk (in)	N/A
N/A	Any Obstructions?	N/A	N/A	Storm Grate/Utility Hazard?	N/A
	Obstruction Type			Storm Grate/Utility Type	
		N/A			N/A
			Yes	Surface Condition? (G/P)	Good

Possible Solutions:

Remove & Replace Curb Ramp With Two New Directional Ramps or Equivalent.

Not Found, R304.2.2

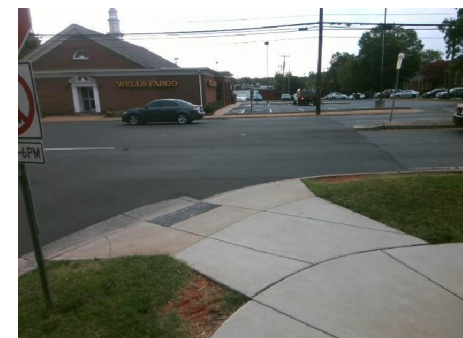
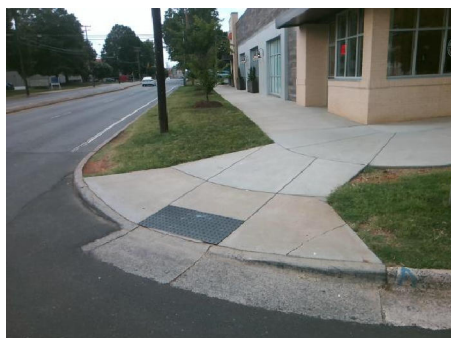
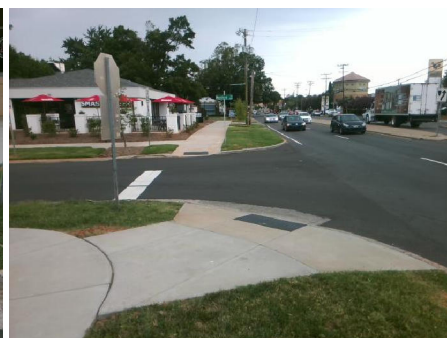
Street 1 Name PARK RD
 Stop Condition-Street 2 None
 Street 2 Name MONTFORD DR
 Stop Condition-Street 1 StopSign
