# Access Compliance Report

## Public Rights-of-Way

### (Curb Ramps)

Intersection ID: 52490	Main Street: WHITEHALL_EXECUTIVE_CENTER_DR	Cross Street: PRAGUE_LN	Location: S
ADA ID: 5F094439A61A	Ramp Type: Perp	Initial Pass/Fail: Fail	Overall Compliance: No
Severity Score: 13.75			
Codes/Mitigation Info/Possible Solution		Field Measurements/Component Compliance

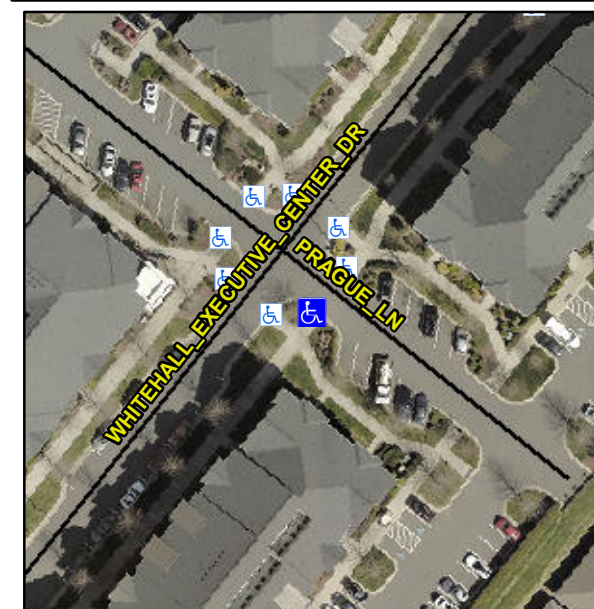
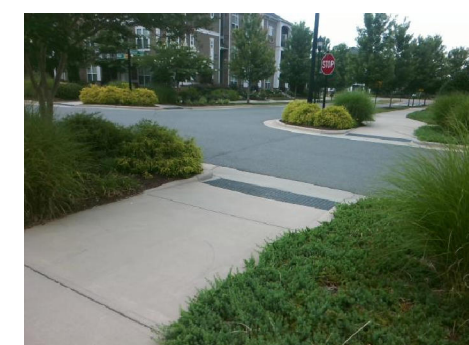
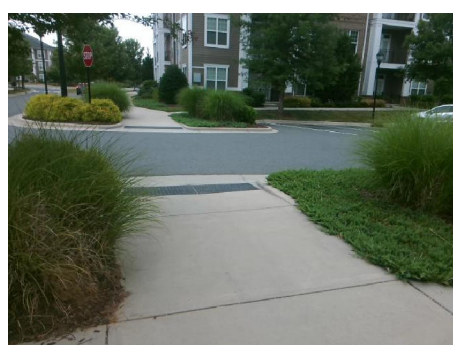
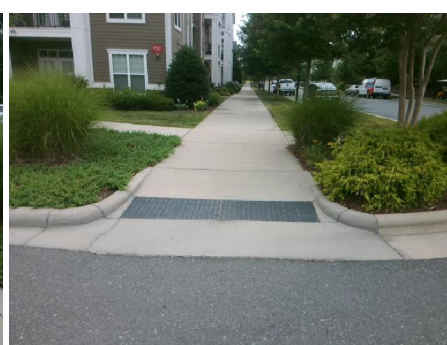
**Not Found, R304.2.2, R304.5.3**

Compliance	Description	Data	Compliance	Description	Data
N/A	Ramp Length (in)	70.0	No	Ramp Slope (%)	8.7
Yes	Ramp Width (in)	93.0	No	Ramp XSlope (%)	2.5
N/A	Flare Type LT	N/A	N/A	Flare Type RT	N/A
N/A	Flare Slope LT (%)	N/A	N/A	Flare Slope RT (%)	N/A
N/A	Flare Traversable LT?	N/A	N/A	Flare Traversable RT?	N/A
N/A	Landing Length (in)	N/A	N/A	DWS Provided?	N/A
N/A	Landing Width (in)	N/A	N/A	DWS Contrast?	N/A
N/A	Landing Slope (%)	N/A	N/A	DWS Length (in)	N/A
N/A	Landing X Slope (%)	N/A	N/A	DWS Full Width?	N/A
N/A	Landing Curb? (Y/N)	N/A	N/A	DWS Offset (in)	N/A
N/A	Shared Landing?	N/A			
N/A	Gutter Ponding?	N/A	N/A	Gutter Slope (%)	N/A
N/A	Gutter Lip Ht (in)	N/A	N/A	Gutter X Slope (%)	N/A
N/A	Painted X Walk1?	No	N/A	Painted X Walk2?	N/A
	X Walk 1 Direction	To NE		X Walk 2 Direction	N/A
N/A	X Walk 1 Width (in)	N/A	N/A	X Walk 2 Width (in)	N/A
	X Walk 1 Slope (%)	1.1		X Walk 2 Slope (%)	N/A
	X Walk 1 X Slope (%)	2.2		X Walk 2 X Slope (%)	N/A

N/A	Ramp inside XWalk1?	N/A	N/A	Ramp inside XWalk2?	N/A
	Road Slope (%)	N/A	N/A	Clear Space?	N/A
	Road X Slope (%)	N/A	N/A	Clear Space to XWalk (in)	N/A
N/A	Any Obstructions?	N/A	N/A	Storm Grate/Utility Hazard?	N/A
	Obstruction Type			Storm Grate/Utility Type	
		N/A			N/A
			Yes	Surface Condition? (G/P)	Good

**Remove & Replace Entire Ramp.**

Total Cost: \$ 1850.00
