Access Compliance Report

Public Rights-of-Way

(Curb Ramps)

| Intersection ID: 20056 | Main Street: COLONY_RD | Cross Street: GOVERNORS_HILL_LN | Location: SE |

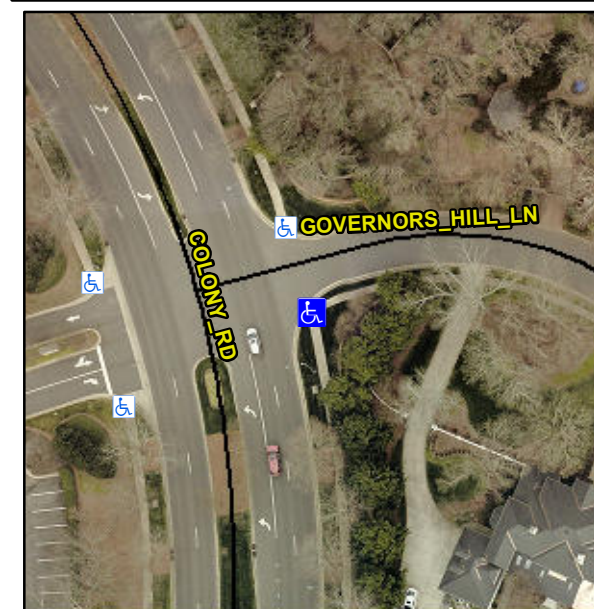
CURB GAP 1.0"

R304.5.3

| Compliance | Description | Data | Compliance | Description | Data |
|---|---|---|---|---|---|
| No | Ramp XSlope (%) | 4.4 | | | |

Remove & Replace Entire Ramp.
