Access Compliance Report

Public Rights-of-Way

(Curb Ramps)

Intersection ID: N/A	Main Street: TRYON_ST	Cross Street: BRONWIN_ST	Location: SW
ADA ID: 5F0B11859577	Ramp Type: Perp	Initial Pass/Fail: Fail	Overall Compliance: No
Severity Score: 21.25			
Codes/Mitigation Info/Possible Solution		Field Measurements/Component Compliance

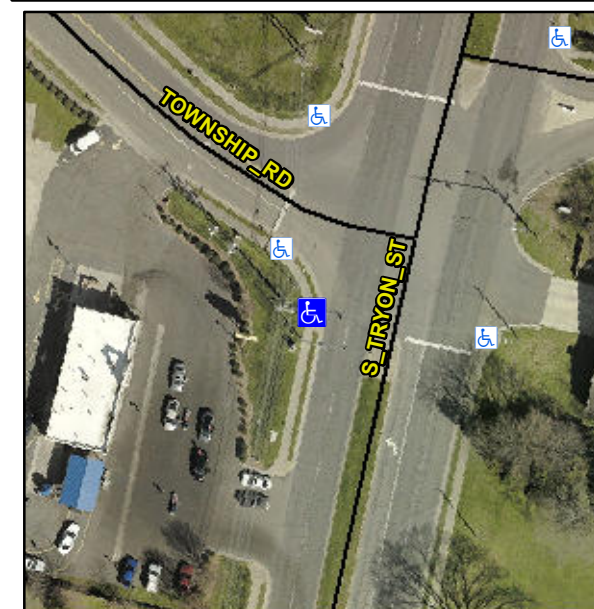
Not Found, R304.5.1, R304.2.2

Compliance	Description	Data	Compliance	Description	Data
N/A	Ramp Length (in)	33.0	No	Ramp Slope (%)	10.4
No	Ramp Width (in)	44.0	Yes	Ramp XSlope (%)	0.5
N/A	Flare Type LT	N/A	N/A	Flare Type RT	N/A
N/A	Flare Slope LT (%)	N/A	N/A	Flare Slope RT (%)	N/A
N/A	Flare Traversable LT?	N/A	N/A	Flare Traversable RT?	N/A
N/A	Landing Length (in)	N/A	N/A	DWS Provided?	N/A
N/A	Landing Width (in)	N/A	N/A	DWS Contrast?	N/A
N/A	Landing Slope (%)	N/A	N/A	DWS Length (in)	N/A
N/A	Landing X Slope (%)	N/A	N/A	DWS Full Width?	N/A
N/A	Landing Curb? (Y/N)	N/A	N/A	DWS Offset (in)	N/A
N/A	Shared Landing?	N/A			
N/A	Gutter Ponding?	N/A	N/A	Gutter Slope (%)	N/A
N/A	Gutter Lip Ht (in)	N/A	N/A	Gutter X Slope (%)	N/A
N/A	Painted X Walk1?	No	N/A	Painted X Walk2?	N/A
	X Walk 1 Direction	To SE		X Walk 2 Direction	N/A
N/A	X Walk 1 Width (in)	N/A	N/A	X Walk 2 Width (in)	N/A
	X Walk 1 Slope (%)	1.4		X Walk 2 Slope (%)	N/A
	X Walk 1 X Slope (%)	0.5		X Walk 2 X Slope (%)	N/A

N/A	Ramp inside XWalk1?	N/A	N/A	Ramp inside XWalk2?	N/A
	Road Slope (%)	N/A	N/A	Clear Space?	N/A
	Road X Slope (%)	N/A	N/A	Clear Space to XWalk (in)	N/A
N/A	Any Obstructions?	N/A	N/A	Storm Grate/Utility Hazard?	N/A
	Obstruction Type			Storm Grate/Utility Type	
		N/A			N/A
			Yes	Surface Condition? (G/P)	Good

Possible Solutions:

Remove & Replace Entire Ramp.

Total Cost: \$ 1850.00
