# Access Compliance Report

## Public Rights-of-Way

### (Curb Ramps)

| Intersection ID: 19275 | Main Street: PEBBLESTONE_DR | Cross Street: VILLAGE_LAKE_DR | Location: NE |

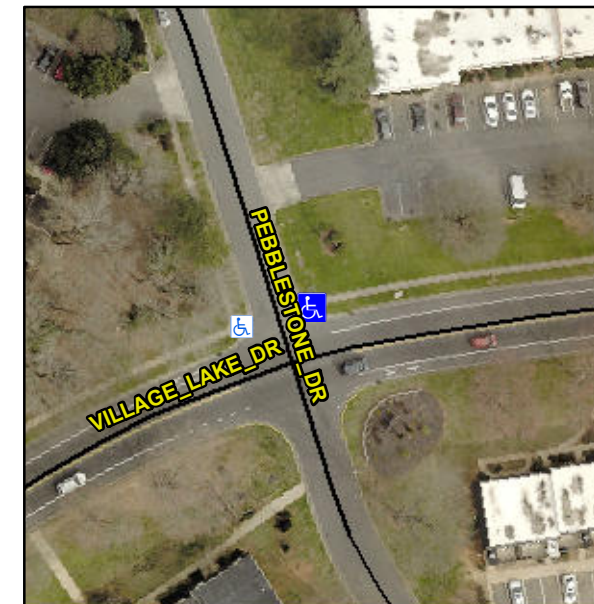
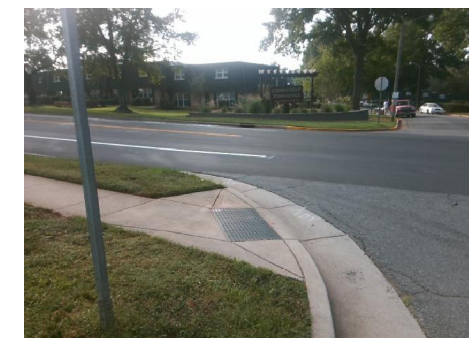
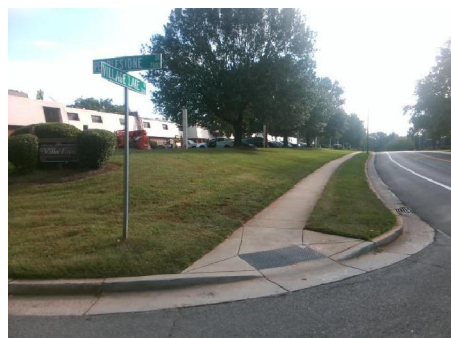
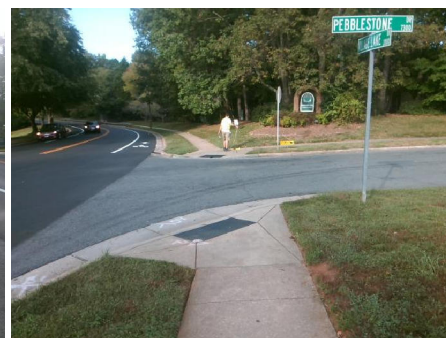
| ADA ID: 5F146E24A74C | Ramp Type: PerpDiag | Initial Pass/Fail: Fail | Overall Compliance: No |
| | | Severity Score: 12.5 | |

**Not Found, R304.2.2**

| Compliance | Description | Data | Compliance | Description | Data |
|---|---|---|---|---|---|
| N/A | Ramp Length (in) | 84.0 | No | Ramp Slope (%) | 9.6 |
| Yes | Ramp Width (in) | 48.0 | Yes | Ramp XSlope (%) | 0.1 |

**Remove & Replace Curb Ramp With Two New Directional Ramps or Equivalent.**

Total Cost: \$ 3200.00
