# Access Compliance Report

## Public Rights-of-Way (Curb Ramps)

| Intersection ID: 45731 | Main Street: REDWOOD VALLEY LN | Cross Street: PROVENCE LN | Location: SW |
| ADA ID: 5F1E2B83CACD | Ramp Type: PerpDiag | Initial Pass/Fail: Fail | Overall Compliance: No |

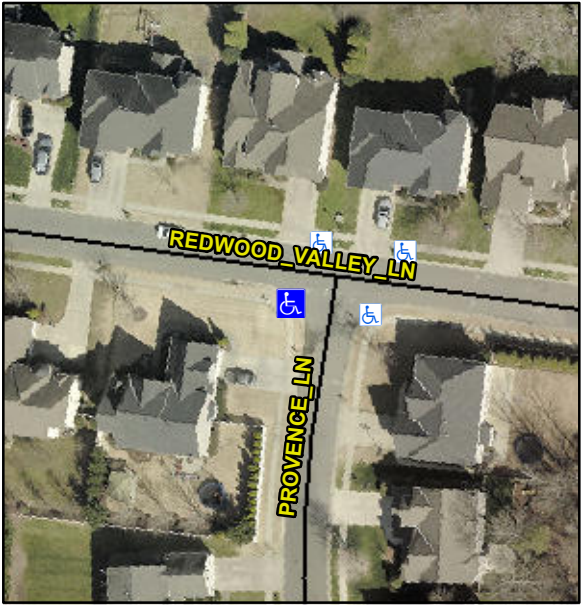
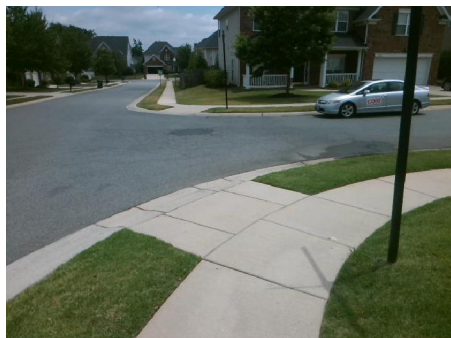
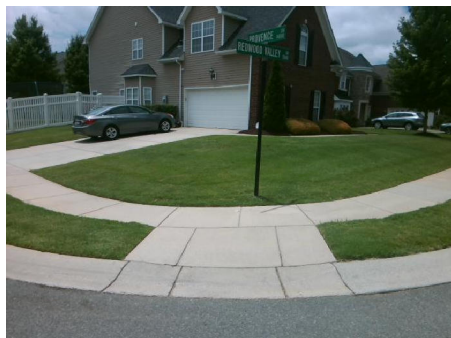
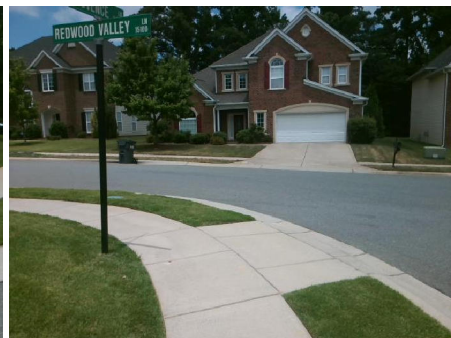
| | | | Severity Score: 33.75 |

| Codes/Mitigation Info/Possible Solution | | | Field Measurements/Component Compliance | | |
|---|---|--|---|---|---|
| | | | No | Ramp Width (in) | 43.0 |
| <p>Surveyor Notes:</p> <p>N/A</p> <p>PROW/ADA:</p> <p>Not Found, R304.5.1, R304.2.2, R304.5.3</p> | | | N/A | Flare Type RT | N/A |

| Codes/Mitigation Info/Possible Solution | | | Field Measurements/Component Compliance | | |
|---|---|--|---|---|---|
| | Remove & Replace Curb Ramp With Two New Directional Ramps or Equivalent. | | N/A | Ramp Length (in) | 49.0 |
