Access Compliance Report

Public Rights-of-Way

(Curb Ramps)

Intersection ID: 46304	Main Street: AUGUSTINE_WY	Cross Street: MERMANS_RD	Location: SE
ADA ID: 5F30F088CE27	Ramp Type: Perp	Initial Pass/Fail: Fail	Overall Compliance: No
Severity Score: 22.5			
Codes/Mitigation Info/Possible Solution		Field Measurements/Component Compliance

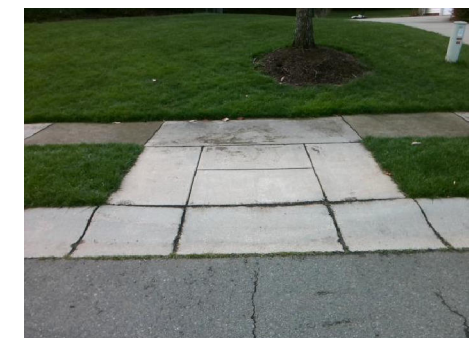
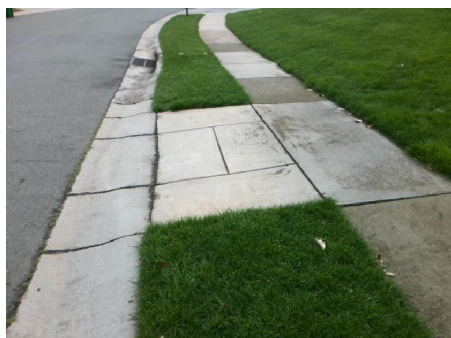
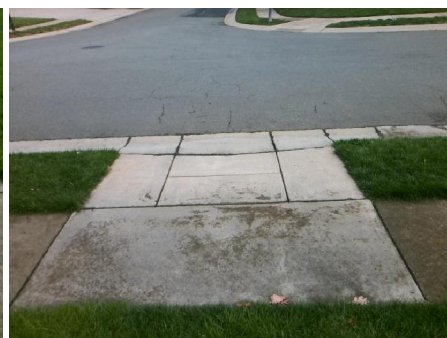
Not Found, R304.5.1, R304.2.2, R304.5.3

Compliance	Description	Data	Compliance	Description	Data
N/A	Ramp Length (in)	48.0	No	Ramp Slope (%)	10.6
No	Ramp Width (in)	45.5	No	Ramp XSlope (%)	2.2
N/A	Flare Type LT	N/A	N/A	Flare Type RT	N/A
N/A	Flare Slope LT (%)	N/A	N/A	Flare Slope RT (%)	N/A
N/A	Flare Traversable LT?	N/A	N/A	Flare Traversable RT?	N/A
N/A	Landing Length (in)	N/A	N/A	DWS Provided?	N/A
N/A	Landing Width (in)	N/A	N/A	DWS Contrast?	N/A
N/A	Landing Slope (%)	N/A	N/A	DWS Length (in)	N/A
N/A	Landing X Slope (%)	N/A	N/A	DWS Full Width?	N/A
N/A	Landing Curb? (Y/N)	N/A	N/A	DWS Offset (in)	N/A
N/A	Shared Landing?	N/A			
N/A	Gutter Ponding?	N/A	N/A	Gutter Slope (%)	N/A
N/A	Gutter Lip Ht (in)	N/A	N/A	Gutter X Slope (%)	N/A
N/A	Painted X Walk1?	No	N/A	Painted X Walk2?	N/A
	X Walk 1 Direction	To N		X Walk 2 Direction	N/A
N/A	X Walk 1 Width (in)	N/A	N/A	X Walk 2 Width (in)	N/A
	X Walk 1 Slope (%)	2.6		X Walk 2 Slope (%)	N/A
	X Walk 1 X Slope (%)	2.0		X Walk 2 X Slope (%)	N/A

N/A	Ramp inside XWalk1?	N/A	N/A	Ramp inside XWalk2?	N/A
	Road Slope (%)	N/A	N/A	Clear Space?	N/A
	Road X Slope (%)	N/A	N/A	Clear Space to XWalk (in)	N/A
N/A	Any Obstructions?	N/A	N/A	Storm Grate/Utility Hazard?	N/A
	Obstruction Type			Storm Grate/Utility Type	
		N/A			N/A
			Yes	Surface Condition? (G/P)	Good

Remove & Replace Entire Ramp.
