# Access Compliance Report

## Public Rights-of-Way

### (Curb Ramps)

Intersection ID: N/A	Main Street: PROVIDENCE_RD	Cross Street: ARBORETUM_DR	Location: NE
ADA ID: 5F348FC8BBF6	Ramp Type: Perp	Initial Pass/Fail: Fail	Overall Compliance: No
Severity Score: 21.25			
Codes/Mitigation Info/Possible Solution		Field Measurements/Component Compliance

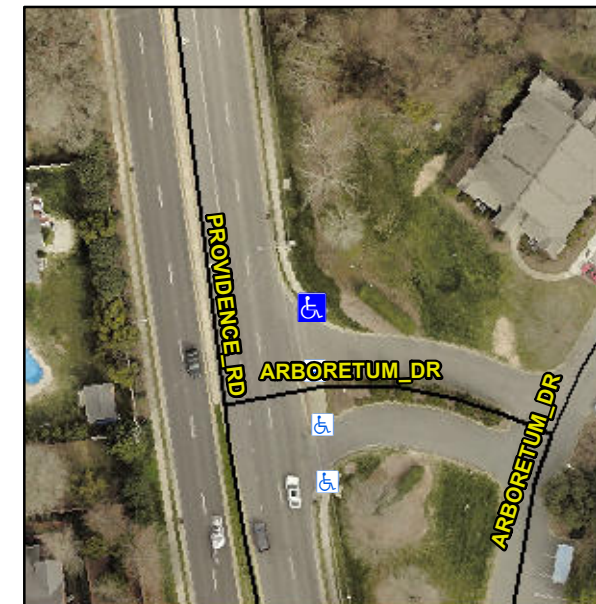
**Not Found, R304.5.1, R304.2.2**

Compliance	Description	Data	Compliance	Description	Data
N/A	Ramp Length (in)	71.5	No	Ramp Slope (%)	11.4
No	Ramp Width (in)	45.0	Yes	Ramp XSlope (%)	1.3
N/A	Flare Type LT	N/A	N/A	Flare Type RT	N/A
N/A	Flare Slope LT (%)	N/A	N/A	Flare Slope RT (%)	N/A
N/A	Flare Traversable LT?	N/A	N/A	Flare Traversable RT?	N/A
N/A	Landing Length (in)	N/A	N/A	DWS Provided?	N/A
N/A	Landing Width (in)	N/A	N/A	DWS Contrast?	N/A
N/A	Landing Slope (%)	N/A	N/A	DWS Length (in)	N/A
N/A	Landing X Slope (%)	N/A	N/A	DWS Full Width?	N/A
N/A	Landing Curb? (Y/N)	N/A	N/A	DWS Offset (in)	N/A
N/A	Shared Landing?	N/A			
N/A	Gutter Ponding?	N/A	N/A	Gutter Slope (%)	N/A
N/A	Gutter Lip Ht (in)	N/A	N/A	Gutter X Slope (%)	N/A
N/A	Painted X Walk1?	No	N/A	Painted X Walk2?	N/A
	X Walk 1 Direction	To S		X Walk 2 Direction	N/A
N/A	X Walk 1 Width (in)	N/A	N/A	X Walk 2 Width (in)	N/A
	X Walk 1 Slope (%)	0.3		X Walk 2 Slope (%)	N/A
	X Walk 1 X Slope (%)	0.2		X Walk 2 X Slope (%)	N/A

N/A	Ramp inside XWalk1?	N/A	N/A	Ramp inside XWalk2?	N/A
	Road Slope (%)	N/A	N/A	Clear Space?	N/A
	Road X Slope (%)	N/A	N/A	Clear Space to XWalk (in)	N/A
N/A	Any Obstructions?	N/A	N/A	Storm Grate/Utility Hazard?	N/A
	Obstruction Type			Storm Grate/Utility Type	
		N/A			N/A
			Yes	Surface Condition? (G/P)	Good

**Remove & Replace Entire Ramp.**

Total Cost: \$ 1850.00
