## Access Compliance Report Public Rights-of-Way (Curb Ramps)

<b></b>	-	,					
Intersection ID: 52535	section ID: 52535 Main Street: TAMARRON_DR				Cross Street: CLAVEMORR_CASTLE_CT				SE
ADA ID: 5F42D2174FE2	Ramp Type: Perp			Initial Pass/Fail: Pass Overall Compliance: N			ice: N	o Severity Score:	5.25
Codes/Mitigation Info/Possible Solution				Field Measurements/Component Compliance					
		Possible Solutions:		Comp	liance Description	Data	Comp	liance Description	Data
		Remove & Replace Entire Ram	<b>D</b> .	N/A	Ramp Length (in)	47.0	Yes	Ramp Slope (%)	8.3
		Remove & Replace Gutter.	•	Yes	Ramp Width (in)	48.0	No	Ramp XSlope (%)	3.2
				N/A	Flare Type LT	Sloped	N/A	Flare Type RT	N/A
				N/A	Flare Slope LT (%)	8.6	Yes	Flare Slope RT (%)	1.7
				N/A	Flare Traversable LT?	Yes	N/A	Flare Traversable RT?	Yes
9 setsing 1 - a				No	Landing Length (in)	47.0	Yes	DWS Provided?	Yes
		Surveyor Notes:		Yes	Landing Width (in)	48.0	Yes	DWS Contrast?	Yes
		N/A		Yes	Landing Slope (%)	0.2	Yes	DWS Length (in)	24.0

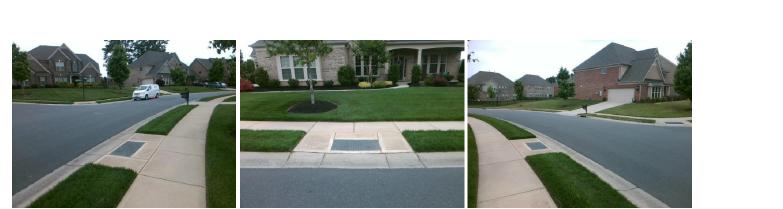
6. 8				Yes	Landing X Slope (%)	2.8	Yes	DWS Full Width?	Yes
				N/A	Landing Curb? (Y/N)	No	No	DWS Offset (in)	4.5
				N/A	Shared Landing?	No			
		PROW/ADA:		Yes	Gutter Ponding?	No	No	Gutter Slope (%)	12.4
		Not Found, R304.5.3, R304.2.		Yes	Gutter Lip Ht (in)	0.0	No	Gutter X Slope (%)	4.0
AT A AN		R305.2, R304.5.4		N/A	Painted X Walk1?	No	N/A	Painted X Walk2?	N/A
					X Walk 1 Direction	To W		X Walk 2 Direction	N/A
6				N/A	X Walk 1 Width (in)	N/A	N/A	X Walk 2 Width (in)	N/A
Street 1 Name	TAMARRON DR				X Walk 1 Slope (%)	2.5		X Walk 2 Slope (%)	N/A
Stop Condition-Street 2	None				X Walk 1 X Slope (%)	2.8		X Walk 2 X Slope (%)	N/A
Street 2 Name	N/A			N/A	Ramp inside XWalk1?	N/A	N/A	Ramp inside XWalk2?	N/A
Stop Condition-Street 1	N/A				Road Slope (%)	N/A	N/A	Clear Space?	Yes
					Road X Slope (%)	N/A	N/A	Clear Space to XWalk (in)	N/A
				Yes	Any Obstructions?	No	Yes	Storm Grate/Utility Hazard?	No
		Total Cost: \$	2600.00		Obstruction Type			Storm Grate/Utility Type
