Access Compliance Report

Public Rights-of-Way

(Curb Ramps)

Intersection ID: N/A	Main Street: KIMMERLY_GLEN_LN	Cross Street: N/A	Location: W
ADA ID: 5F463040691B	Ramp Type: PerpDiag	Initial Pass/Fail: Pass	Overall Compliance: No
Codes/Mitigation Info/Possible Solution		Field Measurements/Component Compliance	
Severity Score: 5

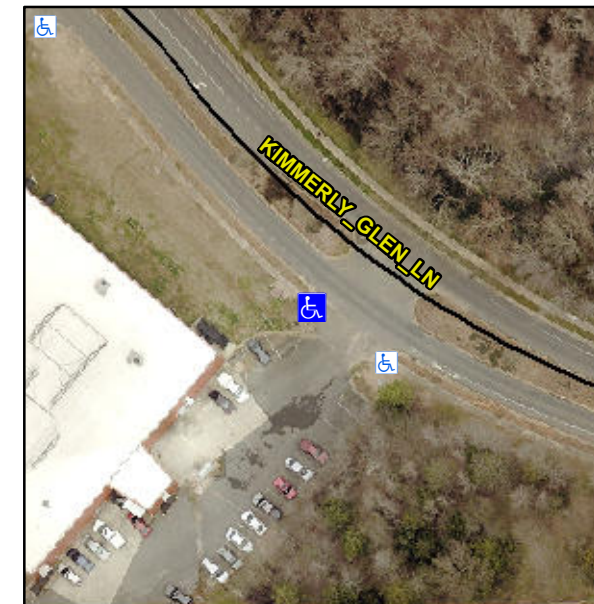
Not Found, R302.7, R304.5.4

Compliance	Description	Data	Compliance	Description	Data
N/A	Ramp Length (in)	33.0	Yes	Ramp Slope (%)	6.5
Yes	Ramp Width (in)	53.0	Yes	Ramp XSlope (%)	1.1
N/A	Flare Type LT	Sloped	N/A	Flare Type RT	N/A
N/A	Flare Slope LT (%)	7.9	N/A	Flare Slope RT (%)	7.2
N/A	Flare Traversable LT?	No	N/A	Flare Traversable RT?	No
Yes	Landing Length (in)	59.0	Yes	DWS Provided?	Yes
Yes	Landing Width (in)	48.0	Yes	DWS Contrast?	Yes
Yes	Landing Slope (%)	0.2	Yes	DWS Length (in)	24.0
Yes	Landing X Slope (%)	1.3	Yes	DWS Full Width?	Yes
N/A	Landing Curb? (Y/N)	No	Yes	DWS Offset (in)	1.5
N/A	Shared Landing?	No			
No	Gutter Ponding?	Yes	No	Gutter Slope (%)	8.8
Yes	Gutter Lip Ht (in)	0.0	Yes	Gutter X Slope (%)	1.3
N/A	Painted X Walk1?	No	N/A	Painted X Walk2?	No
	X Walk 1 Direction	To S		X Walk 2 Direction	To NE
N/A	X Walk 1 Width (in)	N/A	N/A	X Walk 2 Width (in)	N/A
	X Walk 1 Slope (%)	4.2		X Walk 2 Slope (%)	2.4
	X Walk 1 X Slope (%)	3.2		X Walk 2 X Slope (%)	0.8

N/A	Ramp inside XWalk1?	N/A	N/A	Ramp inside XWalk2?	N/A
	Road Slope (%)	0.4	N/A	Clear Space?	Yes
	Road X Slope (%)	1.5	N/A	Clear Space to XWalk (in)	N/A
Yes	Any Obstructions?	No	Yes	Storm Grate/Utility Hazard?	No
	Obstruction Type			Storm Grate/Utility Type	
		N/A			N/A
			Yes	Surface Condition? (G/P)	Good

Remove & Replace Curb Slope and Extend Ramp. Remove & Replace Gutter.
