Access Compliance Report

Public Rights-of-Way

(Curb Ramps)

Intersection ID: 3642	Main Street: PERIMETER_WOODS_DR	Cross Street: PERIMETER_PY	Location: SE
ADA ID: 5F4A8E48C61B	Ramp Type: Perp	Initial Pass/Fail: Fail	Overall Compliance: No
Severity Score: 10			
Codes/Mitigation Info/Possible Solution		Field Measurements/Component Compliance

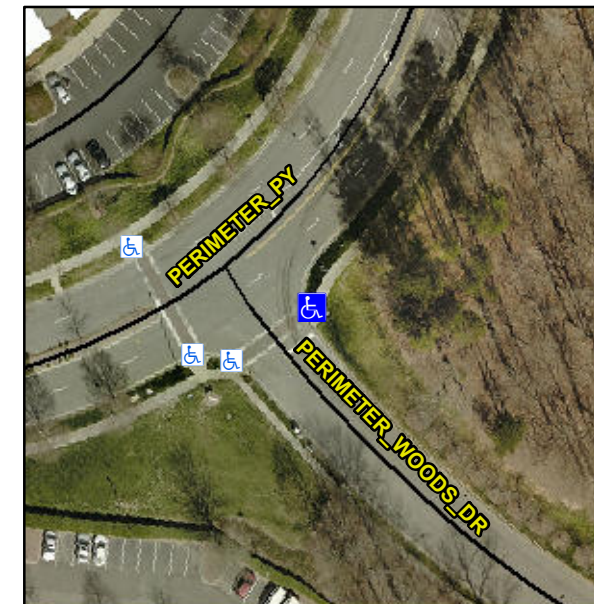
Not Found, R304.5.1, R304.5.3

Compliance	Description	Data	Compliance	Description	Data
N/A	Ramp Length (in)	59.5	Yes	Ramp Slope (%)	7.3
No	Ramp Width (in)	47.5	No	Ramp XSlope (%)	3.1
N/A	Flare Type LT	N/A	N/A	Flare Type RT	N/A
N/A	Flare Slope LT (%)	N/A	N/A	Flare Slope RT (%)	N/A
N/A	Flare Traversable LT?	N/A	N/A	Flare Traversable RT?	N/A
N/A	Landing Length (in)	N/A	N/A	DWS Provided?	N/A
N/A	Landing Width (in)	N/A	N/A	DWS Contrast?	N/A
N/A	Landing Slope (%)	N/A	N/A	DWS Length (in)	N/A
N/A	Landing X Slope (%)	N/A	N/A	DWS Full Width?	N/A
N/A	Landing Curb? (Y/N)	N/A	N/A	DWS Offset (in)	N/A
N/A	Shared Landing?	N/A			
N/A	Gutter Ponding?	N/A	N/A	Gutter Slope (%)	N/A
N/A	Gutter Lip Ht (in)	N/A	N/A	Gutter X Slope (%)	N/A
N/A	Painted X Walk1?	Yes	N/A	Painted X Walk2?	N/A
	X Walk 1 Direction	To SW		X Walk 2 Direction	N/A
N/A	X Walk 1 Width (in)	71.0	N/A	X Walk 2 Width (in)	N/A
	X Walk 1 Slope (%)	2.2		X Walk 2 Slope (%)	N/A
	X Walk 1 X Slope (%)	3.5		X Walk 2 X Slope (%)	N/A

N/A	Ramp inside XWalk1?	Yes	N/A	Ramp inside XWalk2?	N/A
	Road Slope (%)	N/A	N/A	Clear Space?	N/A
	Road X Slope (%)	N/A	N/A	Clear Space to XWalk (in)	N/A
N/A	Any Obstructions?	N/A	N/A	Storm Grate/Utility Hazard?	N/A
	Obstruction Type			Storm Grate/Utility Type	
		N/A			N/A
		Yes		Surface Condition? (G/P)	Good

Possible Solutions:

Remove & Replace Entire Ramp.
