Access Compliance Report

Public Rights-of-Way

(Curb Ramps)

Intersection ID: 42773	Main Street: ERWIN_RIDGE_AV	Cross Street: SWANSONG_LN	Location: N
ADA ID: 5F4B78A9EF18	Ramp Type: PerpDiag	Initial Pass/Fail: Pass	Overall Compliance: No
Codes/Mitigation Info/Possible Solution		Field Measurements/Component Compliance

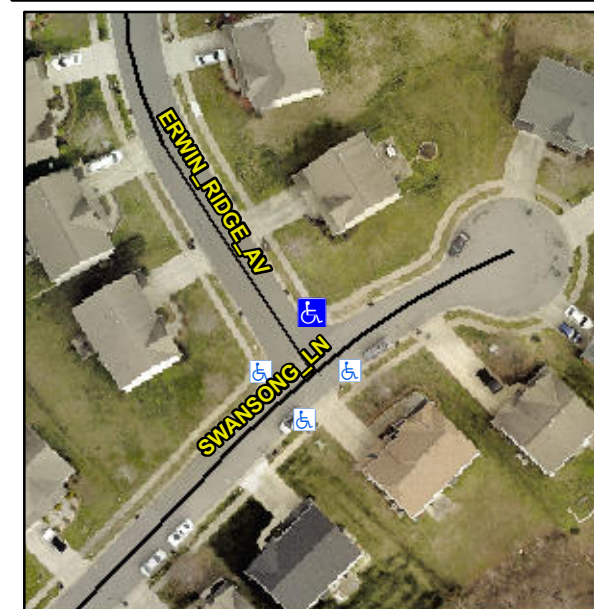
Not Found, R304.5.3, R305, R304.5.4

Compliance	Description	Data	Compliance	Description	Data
N/A	Ramp Length (in)	45.0	Yes	Ramp Slope (%)	6.9
Yes	Ramp Width (in)	48.0	No	Ramp XSlope (%)	2.7
N/A	Flare Type LT	Sloped	N/A	Flare Type RT	N/A
N/A	Flare Slope LT (%)	9.1	N/A	Flare Slope RT (%)	1.0
N/A	Flare Traversable LT?	No	N/A	Flare Traversable RT?	No
Yes	Landing Length (in)	48.0	No	DWS Provided?	No
Yes	Landing Width (in)	48.0	N/A	DWS Contrast?	No
Yes	Landing Slope (%)	2.0	N/A	DWS Length (in)	N/A
No	Landing X Slope (%)	4.1	N/A	DWS Full Width?	No
N/A	Landing Curb? (Y/N)	No	N/A	DWS Offset (in)	N/A
N/A	Shared Landing?	No			
Yes	Gutter Ponding?	No	No	Gutter Slope (%)	7.1
Yes	Gutter Lip Ht (in)	0.0	No	Gutter X Slope (%)	3.5
N/A	Painted X Walk1?	No	N/A	Painted X Walk2?	No
	X Walk 1 Direction	To SW		X Walk 2 Direction	To SE
N/A	X Walk 1 Width (in)	N/A	N/A	X Walk 2 Width (in)	N/A
	X Walk 1 Slope (%)	4.3		X Walk 2 Slope (%)	0.3
	X Walk 1 X Slope (%)	2.2		X Walk 2 X Slope (%)	4.5

N/A	Ramp inside XWalk1?	N/A	N/A	Ramp inside XWalk2?	N/A
	Road Slope (%)	2.8	N/A	Clear Space?	Yes
	Road X Slope (%)	3.1	N/A	Clear Space to XWalk (in)	N/A
Yes	Any Obstructions?	No	Yes	Storm Grate/Utility Hazard?	No
	Obstruction Type			Storm Grate/Utility Type	
		N/A			N/A
			Yes	Surface Condition? (G/P)	Good

Remove & Replace Curb Ramp With Two New Directional Ramps or Equivalent. Remove & Replace Gutter.
