Access Compliance Report Public Rights-of-Way (Curb Ramps)

Intersection ID: 42766 Main Street: MACANTHRA_DR Cross Street: WINSTON_OAKS_CT Location: S

ADA ID: 5F6B3E5133EB Ramp Type: PerpDiag Initial Pass/Fail: Fail Overall Compliance: No Severity Score: 42.5

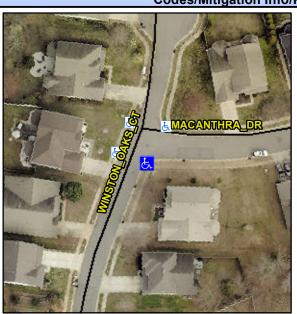
Not Found, R304.5.1, R304.5.3

Compliance Description Data Compliance Description Data					
N/A	Ramp Length (in)	50.0	Yes	Ramp Slope (%)	6.6
No	Ramp Width (in)	32.0	No	Ramp XSlope (%)	8.0
N/A	Flare Type LT	N/A	N/A	Flare Type RT	N/A
N/A	Flare Slope LT (%)	N/A	N/A	Flare Slope RT (%)	N/A
N/A	Flare Traversable LT?	N/A	N/A	Flare Traversable RT?	N/A
N/A	Landing Length (in)	N/A	N/A	DWS Provided?	N/A
N/A	Landing Width (in)	N/A	N/A	DWS Contrast?	N/A
N/A	Landing Slope (%)	N/A	N/A	DWS Length (in)	N/A
N/A	Landing X Slope (%)	N/A	N/A	DWS Full Width?	N/A
N/A	Landing Curb? (Y/N)	N/A	N/A	DWS Offset (in)	N/A
N/A	Shared Landing?	N/A	"	DVVO Oliset (III)	IV/A
N/A	Gutter Ponding?	N/A	N/A	Gutter Slope (%)	N/A
N/A	Gutter Lip Ht (in)	N/A	N/A	Gutter X Slope (%)	N/A
N/A	Painted X Walk1?	No.	N/A	Painted X Walk2?	No.
N/A	X Walk 1 Direction	To NE	IN/A	X Walk 2 Direction	To NW
N/A	X Walk 1 Width (in)	N/A	N/A	X Walk 2 Width (in)	N/A
N/A	` '	3.4	IN/A	` '	4.8
	X Walk 1 Slope (%)	-		X Walk 2 Slope (%)

NI/A	X Walk 1 X Slope (%)	5.2	l NI/A	X Walk 2 X Slope (%)	4.0
N/A	Ramp inside XWalk1?	N/A	N/A	Ramp inside XWalk2?	N/A
	Road Slope (%)	6.9	N/A	Clear Space?	N/A
	Road X Slope (%)	0.1	N/A	Clear Space to XWalk (in)	N/A
N/A	Any Obstructions?	N/A	N/A	Storm Grate/Utility Hazard?	N/A
	Obstruction Type			Storm Grate/Utility Type	
		N/A			N/A

Remove & Replace Curb Ramp With Two New Directional Ramps or Equivalent.

Total Cost: \$ 3200.00
