Access Compliance Report Public Rights-of-Way (Curb Ramps)

Intersection ID: N/A Main Street: GOLF_LINKS_DR Cross Street: WAVERLY_CENTER_DR Location: SE ADA ID: 5F6F5F1B0FDA Ramp Type: Directional1 Initial Pass/Fail: Fail **Overall Compliance: No** Severity Score: 13.75

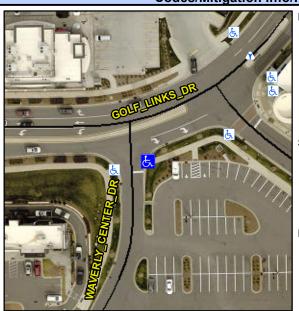
| Field Measurements/Component Compliance | | | | | |
|---|---|---|---|---|---|
| No | Ramp Slope (%) | 10.3 | N/A | Grade Break XSlope (%) | 0.0 |
| No | Ramp XSlope (%) | 4.2 | | | |

Possible Solutions: Remove & Replace Entire Ramp. Surveyor Notes: N/A PROW/ADA: R304.2.2, R304.5.3
