Access Compliance Report

Public Rights-of-Way

(Curb Ramps)

Intersection ID: 27624	Main Street: BALLANTYNE_MEADOWS_DR	Cross Street: JAMES JACK_LN	Location: NW
ADA ID: 5F724441FEA0	Ramp Type: Perp	Initial Pass/Fail: Fail	Overall Compliance: No
		Severity Score: 12.5	
Codes/Mitigation Info/Possible Solution		Field Measurements/Component Compliance

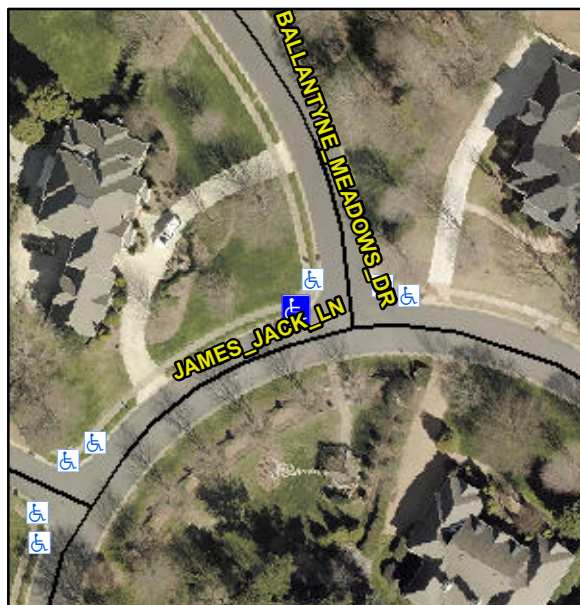
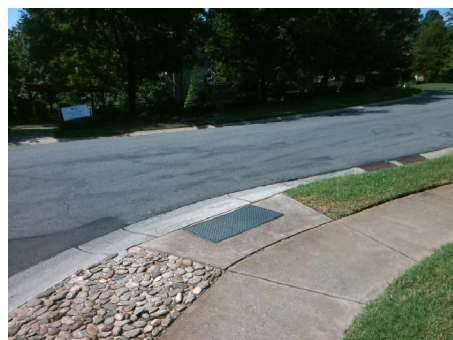
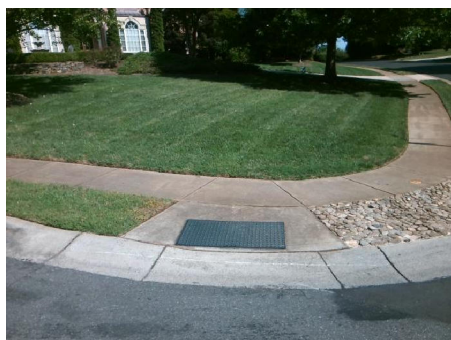
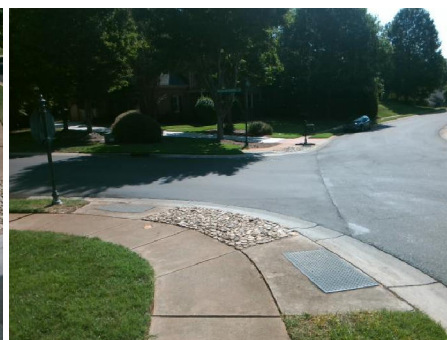
Not Found, R304.5.3

Compliance	Description	Data	Compliance	Description	Data
N/A	Ramp Length (in)	46.0	Yes	Ramp Slope (%)	5.3
Yes	Ramp Width (in)	48.0	No	Ramp XSlope (%)	6.8
N/A	Flare Type LT	N/A	N/A	Flare Type RT	N/A
N/A	Flare Slope LT (%)	N/A	N/A	Flare Slope RT (%)	N/A
N/A	Flare Traversable LT?	N/A	N/A	Flare Traversable RT?	N/A
N/A	Landing Length (in)	N/A	N/A	DWS Provided?	N/A
N/A	Landing Width (in)	N/A	N/A	DWS Contrast?	N/A
N/A	Landing Slope (%)	N/A	N/A	DWS Length (in)	N/A
N/A	Landing X Slope (%)	N/A	N/A	DWS Full Width?	N/A
N/A	Landing Curb? (Y/N)	N/A	N/A	DWS Offset (in)	N/A
N/A	Shared Landing?	N/A			
N/A	Gutter Ponding?	N/A	N/A	Gutter Slope (%)	N/A
N/A	Gutter Lip Ht (in)	N/A	N/A	Gutter X Slope (%)	N/A
N/A	Painted X Walk1?	No	N/A	Painted X Walk2?	N/A
	X Walk 1 Direction	To S		X Walk 2 Direction	N/A
N/A	X Walk 1 Width (in)	N/A	N/A	X Walk 2 Width (in)	N/A
	X Walk 1 Slope (%)	4.9		X Walk 2 Slope (%)	N/A
	X Walk 1 X Slope (%)	4.7		X Walk 2 X Slope (%)	N/A

N/A	Ramp inside XWalk1?	N/A	N/A	Ramp inside XWalk2?	N/A
	Road Slope (%)	N/A	N/A	Clear Space?	N/A
	Road X Slope (%)	N/A	N/A	Clear Space to XWalk (in)	N/A
N/A	Any Obstructions?	N/A	N/A	Storm Grate/Utility Hazard?	N/A
	Obstruction Type			Storm Grate/Utility Type	
		N/A			N/A
		Yes		Surface Condition? (G/P)	Good

Possible Solutions:

Remove & Replace Entire Ramp.

Total Cost: \$ 1850.00
