Access Compliance Report

Public Rights-of-Way

(Curb Ramps)

Intersection ID: 27181	Main Street: MCKEE_RD	Cross Street: PROVIDENCE_PARK_DR	Location: NE
ADA ID: 5F7A5148E807	Ramp Type: Perp	Initial Pass/Fail: Fail	Overall Compliance: No
		Severity Score: 1.25

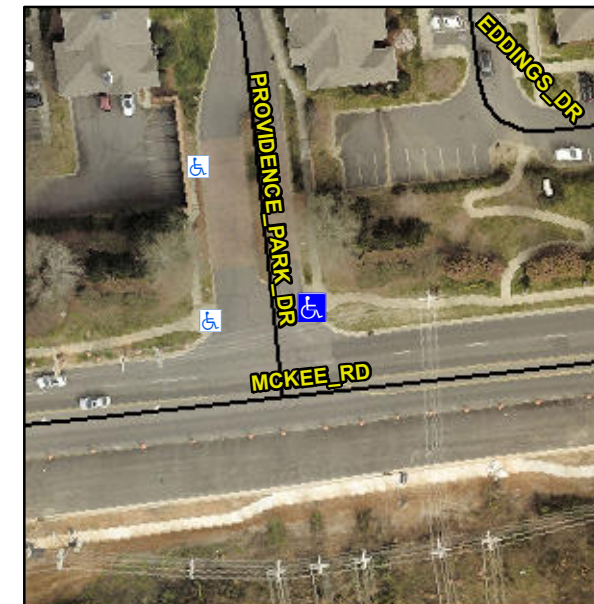
Not Found, R304.5.3

Compliance	Description	Data	Compliance	Description	Data
N/A	Ramp Length (in)	51.0	Yes	Ramp Slope (%)	8.2
Yes	Ramp Width (in)	62.0	No	Ramp XSlope (%)	4.0
N/A	Flare Type LT	N/A	N/A	Flare Type RT	N/A
N/A	Flare Slope LT (%)	N/A	N/A	Flare Slope RT (%)	N/A
N/A	Flare Traversable LT?	N/A	N/A	Flare Traversable RT?	N/A
N/A	Landing Length (in)	N/A	N/A	DWS Provided?	N/A
N/A	Landing Width (in)	N/A	N/A	DWS Contrast?	N/A
N/A	Landing Slope (%)	N/A	N/A	DWS Length (in)	N/A
N/A	Landing X Slope (%)	N/A	N/A	DWS Full Width?	N/A
N/A	Landing Curb? (Y/N)	N/A	N/A	DWS Offset (in)	N/A
N/A	Shared Landing?	N/A			
N/A	Gutter Ponding?	N/A	N/A	Gutter Slope (%)	N/A
N/A	Gutter Lip Ht (in)	N/A	N/A	Gutter X Slope (%)	N/A
N/A	Painted X Walk1?	No	N/A	Painted X Walk2?	N/A
	X Walk 1 Direction	To W		X Walk 2 Direction	N/A
N/A	X Walk 1 Width (in)	N/A	N/A	X Walk 2 Width (in)	N/A
	X Walk 1 Slope (%)	1.4		X Walk 2 Slope (%)	N/A
	X Walk 1 X Slope (%)	5.2		X Walk 2 X Slope (%)	N/A

Remove & Replace Entire Ramp.
