# Access Compliance Report

## Public Rights-of-Way

### (Curb Ramps)

Intersection ID: 10024261	Main Street: CRAIG_AV	Cross Street: N/A	Location: SE
ADA ID: 5F80C92B31E8	Ramp Type: PerpDiag	Initial Pass/Fail: Fail	Overall Compliance: No
Codes/Mitigation Info/Possible Solution		Field Measurements/Component Compliance	
Severity Score: 22.5

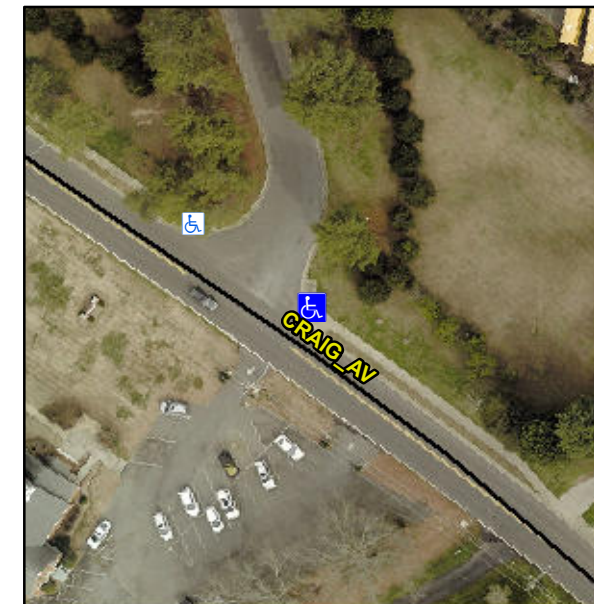
**Not Found, R304.5.1, R304.2.2, R304.5.3**

Compliance	Description	Data	Compliance	Description	Data
N/A	Ramp Length (in)	76.0	No	Ramp Slope (%)	8.7
No	Ramp Width (in)	39.5	No	Ramp XSlope (%)	3.3
N/A	Flare Type LT	N/A	N/A	Flare Type RT	N/A
N/A	Flare Slope LT (%)	N/A	N/A	Flare Slope RT (%)	N/A
N/A	Flare Traversable LT?	N/A	N/A	Flare Traversable RT?	N/A
N/A	Landing Length (in)	N/A	N/A	DWS Provided?	N/A
N/A	Landing Width (in)	N/A	N/A	DWS Contrast?	N/A
N/A	Landing Slope (%)	N/A	N/A	DWS Length (in)	N/A
N/A	Landing X Slope (%)	N/A	N/A	DWS Full Width?	N/A
N/A	Landing Curb? (Y/N)	N/A	N/A	DWS Offset (in)	N/A
N/A	Shared Landing?	N/A			
N/A	Gutter Ponding?	N/A	N/A	Gutter Slope (%)	N/A
N/A	Gutter Lip Ht (in)	N/A	N/A	Gutter X Slope (%)	N/A
N/A	Painted X Walk1?	No	N/A	Painted X Walk2?	No
	X Walk 1 Direction	To NW		X Walk 2 Direction	To SW
N/A	X Walk 1 Width (in)	N/A	N/A	X Walk 2 Width (in)	N/A
	X Walk 1 Slope (%)	0.7		X Walk 2 Slope (%)	1.5
	X Walk 1 X Slope (%)	1.3		X Walk 2 X Slope (%)	3.2

N/A	Ramp inside XWalk1?	N/A	N/A	Ramp inside XWalk2?	N/A
	Road Slope (%)	1.9	N/A	Clear Space?	N/A
	Road X Slope (%)	0.7	N/A	Clear Space to XWalk (in)	N/A
N/A	Any Obstructions?	N/A	N/A	Storm Grate/Utility Hazard?	N/A
	Obstruction Type			Storm Grate/Utility Type	
		N/A			N/A
			Yes	Surface Condition? (G/P)	Good

**Remove & Replace Curb Ramp With Two New Directional Ramps or Equivalent.**
