Access Compliance Report

Public Rights-of-Way

(Curb Ramps)

Intersection ID: 11349	Main Street: N_DAVIDSON_ST	Cross Street: PARKWOOD_AV	Location: W
ADA ID: 5F80F32FEB6F	Ramp Type: Perp	Initial Pass/Fail: Fail	Overall Compliance: No
Severity Score: 21.25			
Codes/Mitigation Info/Possible Solution		Field Measurements/Component Compliance

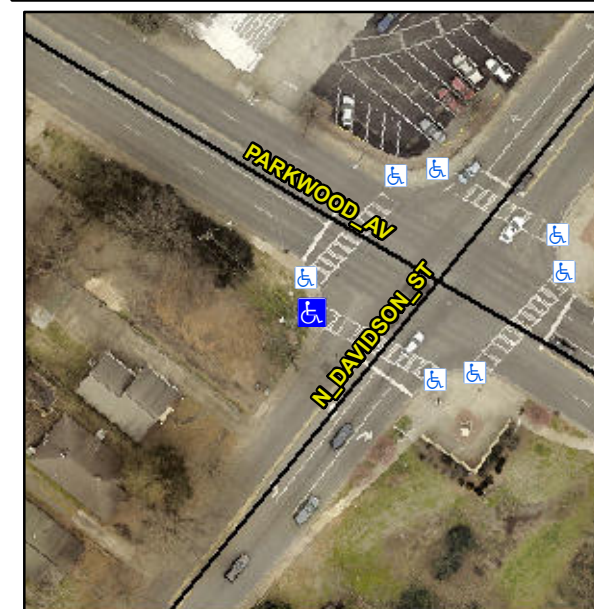
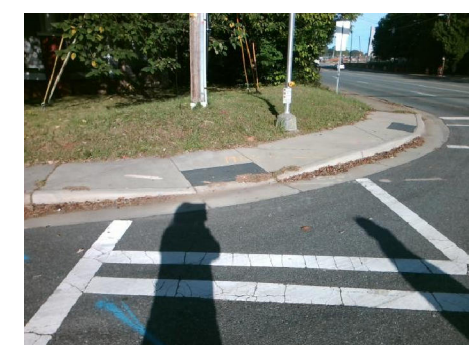
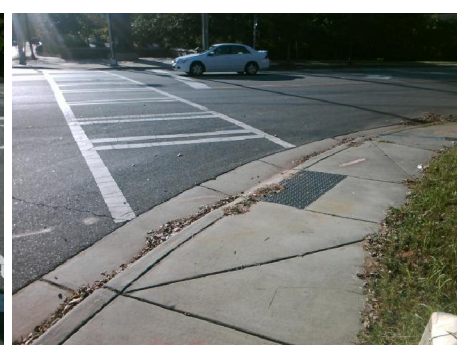
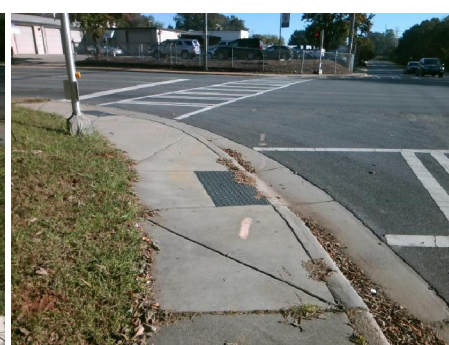
Not Found, R304.5.1, R304.2.2

Compliance	Description	Data	Compliance	Description	Data
N/A	Ramp Length (in)	59.5	No	Ramp Slope (%)	9.7
No	Ramp Width (in)	46.5	Yes	Ramp XSlope (%)	1.8
N/A	Flare Type LT	N/A	N/A	Flare Type RT	N/A
N/A	Flare Slope LT (%)	N/A	N/A	Flare Slope RT (%)	N/A
N/A	Flare Traversable LT?	N/A	N/A	Flare Traversable RT?	N/A
N/A	Landing Length (in)	N/A	N/A	DWS Provided?	N/A
N/A	Landing Width (in)	N/A	N/A	DWS Contrast?	N/A
N/A	Landing Slope (%)	N/A	N/A	DWS Length (in)	N/A
N/A	Landing X Slope (%)	N/A	N/A	DWS Full Width?	N/A
N/A	Landing Curb? (Y/N)	N/A	N/A	DWS Offset (in)	N/A
N/A	Shared Landing?	N/A			
N/A	Gutter Ponding?	N/A	N/A	Gutter Slope (%)	N/A
N/A	Gutter Lip Ht (in)	N/A	N/A	Gutter X Slope (%)	N/A
N/A	Painted X Walk1?	Yes	N/A	Painted X Walk2?	N/A
	X Walk 1 Direction	To SE		X Walk 2 Direction	N/A
N/A	X Walk 1 Width (in)	110.0	N/A	X Walk 2 Width (in)	N/A
	X Walk 1 Slope (%)	2.8		X Walk 2 Slope (%)	N/A
	X Walk 1 X Slope (%)	2.3		X Walk 2 X Slope (%)	N/A

N/A	Ramp inside XWalk1?	Yes	N/A	Ramp inside XWalk2?	N/A
	Road Slope (%)	N/A	N/A	Clear Space?	N/A
	Road X Slope (%)	N/A	N/A	Clear Space to XWalk (in)	N/A
N/A	Any Obstructions?	N/A	N/A	Storm Grate/Utility Hazard?	N/A
	Obstruction Type			Storm Grate/Utility Type	
		N/A			N/A
			Yes	Surface Condition? (G/P)	Good

Remove & Replace Entire Ramp.

Total Cost: \$ 1850.00
