# Access Compliance Report

## Public Rights-of-Way

### (Curb Ramps)

Intersection ID: 12978	Main Street: S_CALDWELL_ST	Cross Street: E_MARTIN_LUTHER_KING_JR_BV	Location: NW
ADA ID: 5F8103478AB0	Ramp Type: Perp	Initial Pass/Fail: Fail	Overall Compliance: No
		Severity Score: 12.5

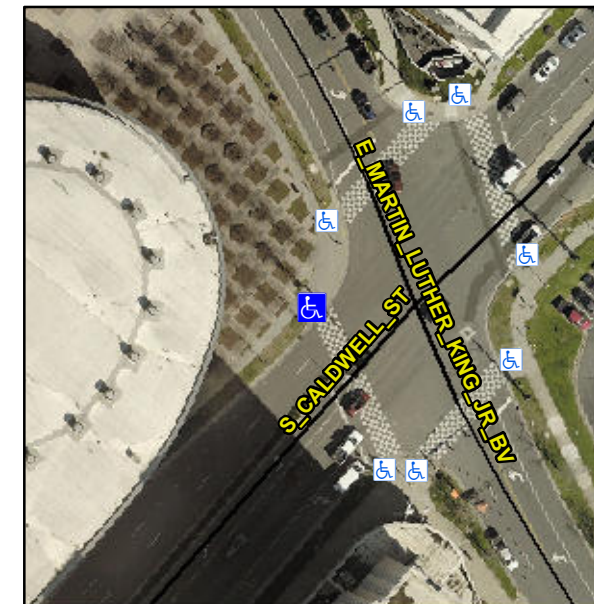
**Not Found, R304.2.2**

Compliance	Description	Data	Compliance	Description	Data
N/A	Ramp Length (in)	80.0	No	Ramp Slope (%)	8.9
Yes	Ramp Width (in)	48.0	Yes	Ramp XSlope (%)	0.2
N/A	Flare Type LT	N/A	N/A	Flare Type RT	N/A
N/A	Flare Slope LT (%)	N/A	N/A	Flare Slope RT (%)	N/A
N/A	Flare Traversable LT?	No	N/A	Flare Traversable RT?	No
N/A	Landing Length (in)	N/A	N/A	DWS Provided?	N/A
N/A	Landing Width (in)	N/A	N/A	DWS Contrast?	N/A
N/A	Landing Slope (%)	N/A	N/A	DWS Length (in)	N/A
N/A	Landing X Slope (%)	N/A	N/A	DWS Full Width?	N/A
N/A	Landing Curb? (Y/N)	N/A	N/A	DWS Offset (in)	N/A
N/A	Shared Landing?	N/A			
N/A	Gutter Ponding?	N/A	N/A	Gutter Slope (%)	N/A
N/A	Gutter Lip Ht (in)	N/A	N/A	Gutter X Slope (%)	N/A
N/A	Painted X Walk1?	Yes	N/A	Painted X Walk2?	N/A
	X Walk 1 Direction	To S		X Walk 2 Direction	N/A
N/A	X Walk 1 Width (in)	144.0	N/A	X Walk 2 Width (in)	N/A
	X Walk 1 Slope (%)	2.3		X Walk 2 Slope (%)	N/A
	X Walk 1 X Slope (%)	1.5		X Walk 2 X Slope (%)	N/A

N/A	Ramp inside XWalk1?	Yes	N/A	Ramp inside XWalk2?	N/A
	Road Slope (%)	N/A	N/A	Clear Space?	N/A
	Road X Slope (%)	N/A	N/A	Clear Space to XWalk (in)	N/A
N/A	Any Obstructions?	N/A	N/A	Storm Grate/Utility Hazard?	N/A
	Obstruction Type			Storm Grate/Utility Type	
		N/A			N/A
			Yes	Surface Condition? (G/P)	Good

**Remove & Replace Entire Ramp.**

Total Cost: \$ 1850.00
