Access Compliance Report

Public Rights-of-Way

(Curb Ramps)

Intersection ID: 53250	Main Street: MAJOR_SAMUALS_WY	Cross Street: ALYSSA_LN	Location: NE
ADA ID: 5F94A7BDDAB2	Ramp Type: Perp	Initial Pass/Fail: Fail	Overall Compliance: No
Codes/Mitigation Info/Possible Solution			Severity Score: 10
			Field Measurements/Component Compliance

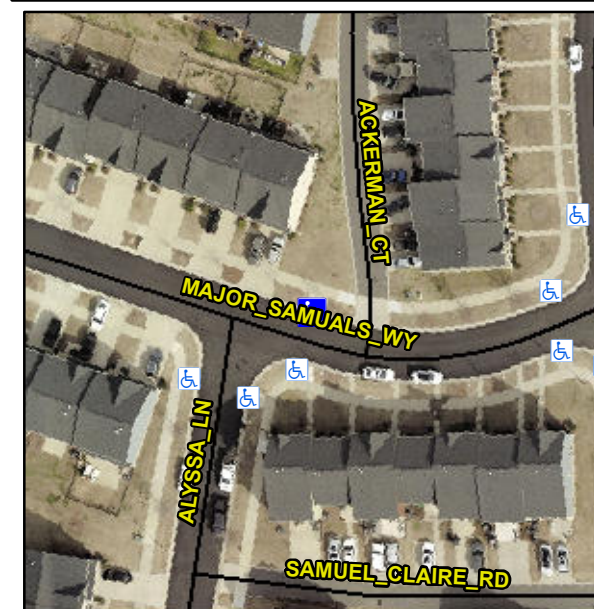
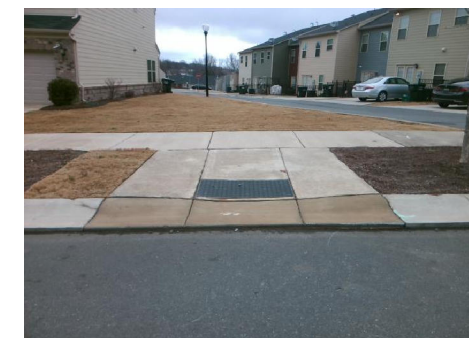
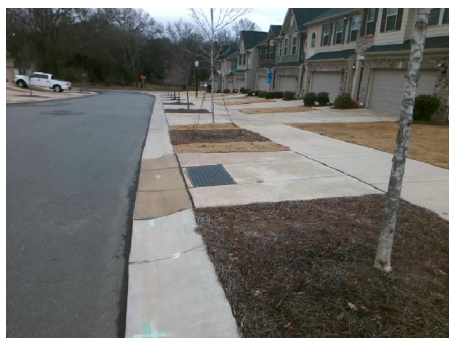
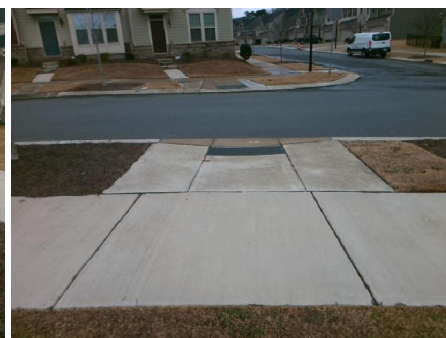
R304.5.1, R304.5.3

Compliance	Description	Data	Compliance	Description	Data
N/A	Ramp Length (in)	95.5	Yes	Ramp Slope (%)	6.8
No	Ramp Width (in)	47.5	No	Ramp XSlope (%)	3.8
N/A	Flare Type LT	N/A	N/A	Flare Type RT	N/A
N/A	Flare Slope LT (%)	N/A	N/A	Flare Slope RT (%)	N/A
N/A	Flare Traversable LT?	N/A	N/A	Flare Traversable RT?	N/A
N/A	Landing Length (in)	N/A	N/A	DWS Provided?	N/A
N/A	Landing Width (in)	N/A	N/A	DWS Contrast?	N/A
N/A	Landing Slope (%)	N/A	N/A	DWS Length (in)	N/A
N/A	Landing X Slope (%)	N/A	N/A	DWS Full Width?	N/A
N/A	Landing Curb? (Y/N)	N/A	N/A	DWS Offset (in)	N/A
N/A	Shared Landing?	N/A			
N/A	Gutter Ponding?	N/A	N/A	Gutter Slope (%)	N/A
N/A	Gutter Lip Ht (in)	N/A	N/A	Gutter X Slope (%)	N/A
N/A	Painted X Walk1?	No	N/A	Painted X Walk2?	N/A
	X Walk 1 Direction	To S		X Walk 2 Direction	N/A
N/A	X Walk 1 Width (in)	N/A	N/A	X Walk 2 Width (in)	N/A
	X Walk 1 Slope (%)	2.1		X Walk 2 Slope (%)	N/A
	X Walk 1 X Slope (%)	3.4		X Walk 2 X Slope (%)	N/A

N/A	Ramp inside XWalk1?	N/A	N/A	Ramp inside XWalk2?	N/A
	Road Slope (%)	N/A	N/A	Clear Space?	N/A
	Road X Slope (%)	N/A	N/A	Clear Space to XWalk (in)	N/A
N/A	Any Obstructions?	N/A	N/A	Storm Grate/Utility Hazard?	N/A
	Obstruction Type			Storm Grate/Utility Type	
		N/A			N/A
			Yes	Surface Condition? (G/P)	Good

Possible Solutions:

Remove & Replace Entire Ramp.
