Access Compliance Report

Public Rights-of-Way (Curb Ramps)

Intersection ID: 45096	Main Street: E_9TH_ST	Cross Street: N_DAVIDSON_ST	Location: E
ADA ID: 5F94C57E0D74	Ramp Type: Directional1	Initial Pass/Fail: Fail	Overall Compliance: No
		Severity Score: 1.25

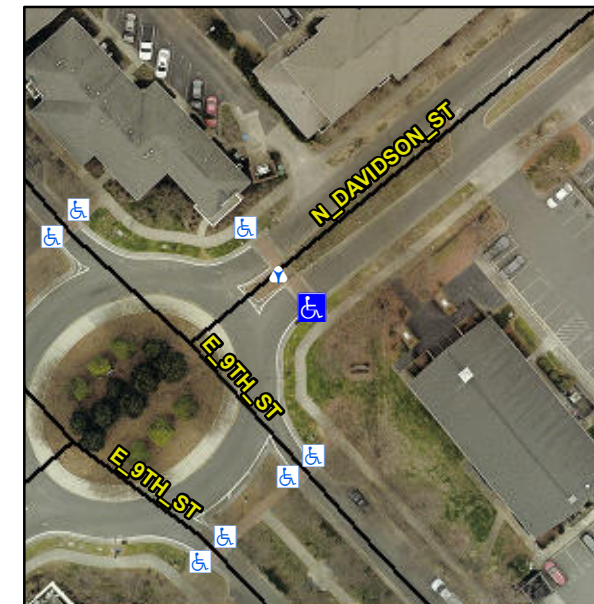
Compliance	Description	Data	Compliance	Description	Data
N/A	Ramp Length (in)	69.0	N/A	Grade Break?	N/A
Yes	Ramp Width (in)	71.0	N/A	Grade Break Slope (%)	0.0
Yes	Ramp Slope (%)	6.6	N/A	Grade Break XSlope (%)	0.0
No	Ramp XSlope (%)	3.6			
N/A	Flare Type LT	N/A	N/A	Flare Type RT	N/A
N/A	Flare Slope LT (%)	N/A	N/A	Flare Slope RT (%)	0.0
N/A	Flare Traversable LT?	N/A	N/A	Flare Traversable RT?	N/A
N/A	Landing Length (in)	0.0	N/A	DWS Provided?	N/A
N/A	Landing Width (in)	0.0	N/A	DWS Contrast?	N/A
N/A	Landing Slope (%)	0.0	N/A	DWS Length (in)	N/A
N/A	Landing X Slope (%)	0.0	N/A	DWS Full Width?	N/A
N/A	Landing Curb? (Y/N)	N/A	N/A	DWS Offset LT (in)	N/A
N/A	Shared Landing?	N/A	N/A	DWS Offset RT (in)	N/A
N/A	Gutter Ponding?	0.0	N/A	Gutter Slope (%)	N/A
N/A	Gutter Lip Ht (in)	0.0	N/A	Gutter X Slope (%)	N/A
N/A	Painted X Walk1?	Yes		Road Slope (%)	3.0
	X Walk 1 Direction	To NW		Road X Slope (%)	3.5
	X Walk 1 Width (in)	82.0		Clear Space?	N/A

X Walk 1 Slope (%)	3.0	N/A	Clear Space to XWalk (in)	N/A
	X Walk 1 X Slope (%)	3.5	N/A	Storm Grate/Utility Hazard?	N/A
N/A	Ramp inside XWalk1?	Yes		Storm Grate/Utility Type	
N/A	Any Obstructions?	N/A			N/A
	Obstruction Type		Yes	Surface Condition? (G/P)	Good
			N/A	Curb Slope (%)	9.2

Remove & Replace Entire Ramp.

R304.5.3

\$ 1600.00
