Access Compliance Report

Public Rights-of-Way

(Curb Ramps)

Intersection ID: 7694	Main Street: LOG_CABIN_RD	Cross Street: THORNWOOD_RD	Location:	S
ADA ID: 5F95936AE5A5	Ramp Type: Perp	Initial Pass/Fail: Fail	Overall Compliance: No	Severity Score: 1.25
Codes/Mitigation Info/Possible Solution		Field Measurements/Component Compliance

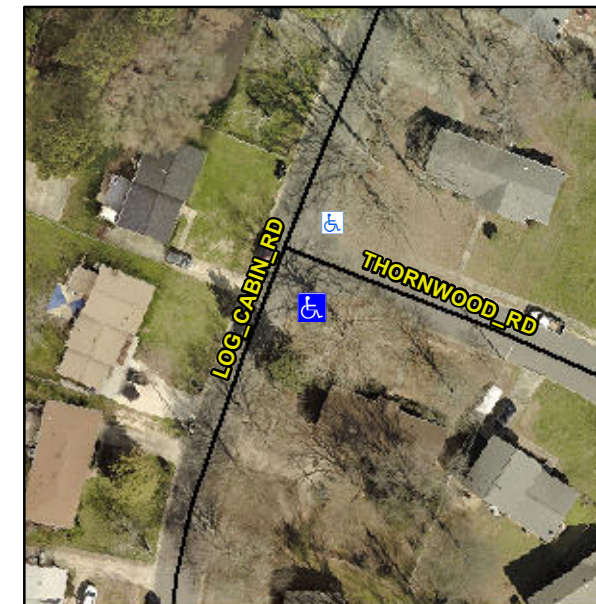
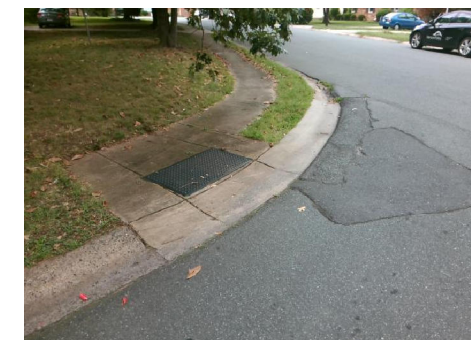
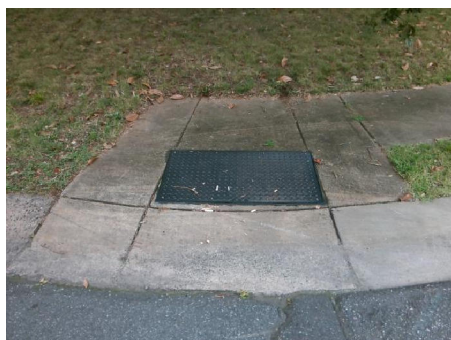
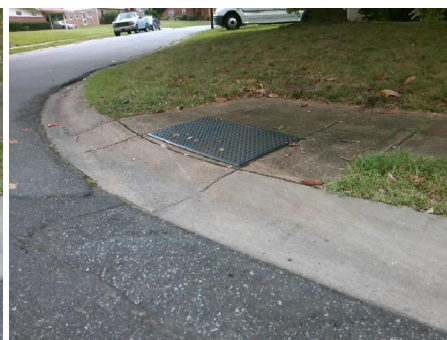
Not Found, R304.5.3

Compliance	Description	Data	Compliance	Description	Data
N/A	Ramp Length (in)	24.5	Yes	Ramp Slope (%)	7.2
Yes	Ramp Width (in)	48.0	No	Ramp XSlope (%)	2.6
N/A	Flare Type LT	N/A	N/A	Flare Type RT	N/A
N/A	Flare Slope LT (%)	N/A	N/A	Flare Slope RT (%)	N/A
N/A	Flare Traversable LT?	N/A	N/A	Flare Traversable RT?	N/A
N/A	Landing Length (in)	N/A	N/A	DWS Provided?	N/A
N/A	Landing Width (in)	N/A	N/A	DWS Contrast?	N/A
N/A	Landing Slope (%)	N/A	N/A	DWS Length (in)	N/A
N/A	Landing X Slope (%)	N/A	N/A	DWS Full Width?	N/A
N/A	Landing Curb? (Y/N)	N/A	N/A	DWS Offset (in)	N/A
N/A	Shared Landing?	N/A			
N/A	Gutter Ponding?	N/A	N/A	Gutter Slope (%)	N/A
N/A	Gutter Lip Ht (in)	0.75	N/A	Gutter X Slope (%)	N/A
N/A	Painted X Walk1?	No	N/A	Painted X Walk2?	N/A
	X Walk 1 Direction	To NE		X Walk 2 Direction	N/A
N/A	X Walk 1 Width (in)	N/A	N/A	X Walk 2 Width (in)	N/A
	X Walk 1 Slope (%)	4.5		X Walk 2 Slope (%)	N/A
	X Walk 1 X Slope (%)	0.2		X Walk 2 X Slope (%)	N/A

N/A	Ramp inside XWalk1?	N/A	N/A	Ramp inside XWalk2?	N/A
	Road Slope (%)	N/A	N/A	Clear Space?	N/A
	Road X Slope (%)	N/A	N/A	Clear Space to XWalk (in)	N/A
N/A	Any Obstructions?	N/A	N/A	Storm Grate/Utility Hazard?	N/A
	Obstruction Type			Storm Grate/Utility Type	
		N/A			N/A
			Yes	Surface Condition? (G/P)	Good

Remove & Replace Entire Ramp.
