Access Compliance Report

Public Rights-of-Way

(Curb Ramps)

Intersection ID: 14585	Main Street: RUBINE_ST	Cross Street: W_TYVOLA_RD	Location: S
ADA ID: 5F99DB827394	Ramp Type: Perp	Initial Pass/Fail: Fail	Overall Compliance: No
		Severity Score: 12.5

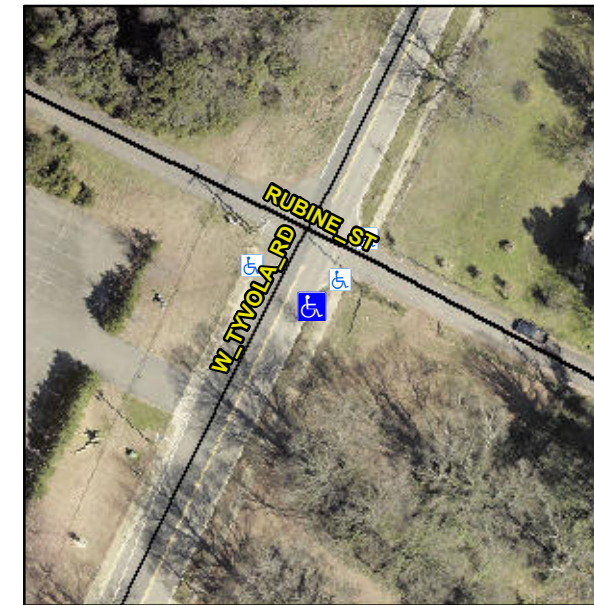
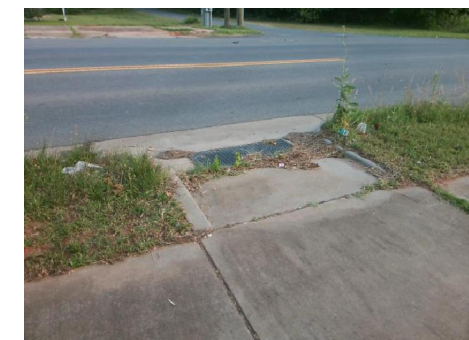
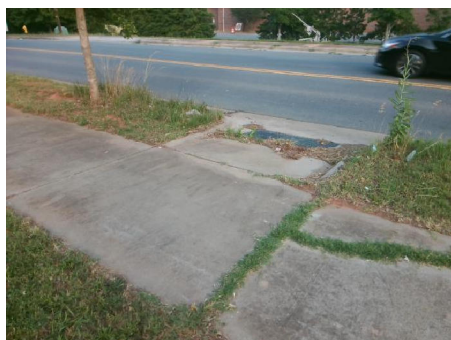
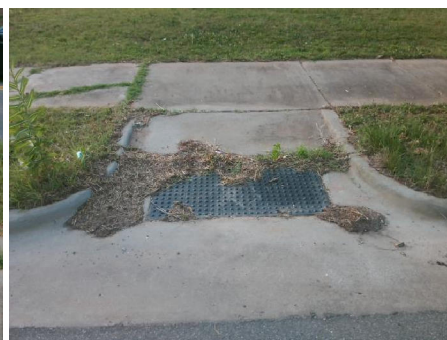
Not Found, R304.2.2

Compliance	Description	Data	Compliance	Description	Data
N/A	Ramp Length (in)	62.0	No	Ramp Slope (%)	9.4
Yes	Ramp Width (in)	70.0	Yes	Ramp XSlope (%)	0.6
N/A	Flare Type LT	N/A	N/A	Flare Type RT	N/A
N/A	Flare Slope LT (%)	N/A	N/A	Flare Slope RT (%)	N/A
N/A	Flare Traversable LT?	N/A	N/A	Flare Traversable RT?	N/A
N/A	Landing Length (in)	N/A	N/A	DWS Provided?	N/A
N/A	Landing Width (in)	N/A	N/A	DWS Contrast?	N/A
N/A	Landing Slope (%)	N/A	N/A	DWS Length (in)	N/A
N/A	Landing X Slope (%)	N/A	N/A	DWS Full Width?	N/A
N/A	Landing Curb? (Y/N)	N/A	N/A	DWS Offset (in)	N/A
N/A	Shared Landing?	N/A			
N/A	Gutter Ponding?	N/A	N/A	Gutter Slope (%)	N/A
N/A	Gutter Lip Ht (in)	N/A	N/A	Gutter X Slope (%)	N/A
N/A	Painted X Walk1?	No	N/A	Painted X Walk2?	N/A
	X Walk 1 Direction	To W		X Walk 2 Direction	N/A
N/A	X Walk 1 Width (in)	N/A	N/A	X Walk 2 Width (in)	N/A
	X Walk 1 Slope (%)	1.9		X Walk 2 Slope (%)	N/A
	X Walk 1 X Slope (%)	0.5		X Walk 2 X Slope (%)	N/A

N/A	Ramp inside XWalk1?	N/A	N/A	Ramp inside XWalk2?	N/A
	Road Slope (%)	N/A	N/A	Clear Space?	N/A
	Road X Slope (%)	N/A	N/A	Clear Space to XWalk (in)	N/A
N/A	Any Obstructions?	N/A	N/A	Storm Grate/Utility Hazard?	N/A
	Obstruction Type			Storm Grate/Utility Type	
		N/A			N/A
			Yes	Surface Condition? (G/P)	Good

Remove & Replace Entire Ramp.
