Access Compliance Report Public Rights-of-Way (Curb Ramps)

Intersection ID: 10995 Main Street: MARBETTA_LN Cross Street: OAK_FOREST_DR Location: W

ADA ID: 5FA22EFB260C Ramp Type: BlendTrans1 Initial Pass/Fail: Fail Overall Compliance: No Severity Score: 21.25

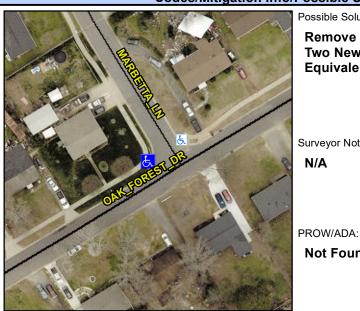
Not Found, R304.5.1, R304.5.3

Fleid Measurements/Component Compnance					
Compliance Description Da		Data	Compliance Description		Data
N/A	Ramp Length (in)	51.5	Yes	BlendTrans Slope (%)	3.0
No	Ramp Width (in)	47.5	No	BlendTrans XSlope (%)	6.8
N/A	Flare Type LT	N/A	N/A	Flare Type RT	N/A
N/A	Flare Slope LT (%)	N/A	N/A	Flare Slope RT (%)	N/A
N/A	Flare Traversable LT?	N/A	N/A	Flare Traversable RT?	N/A
N/A	Landing Length (in)	N/A	N/A	DWS Provided?	N/A
N/A	Landing Width (in)	N/A	N/A	DWS Contrast?	N/A
N/A	Landing Slope (%)	N/A	N/A	DWS Length (in)	N/A
N/A	Landing X Slope (%)	N/A	N/A	DWS Full Width?	N/A
N/A	Landing Curb? (Y/N)	N/A	N/A	DWS Offset (in)	N/A
N/A	Shared Landing?	N/A			
N/A	Gutter Ponding?	N/A	N/A	Gutter Slope (%)	N/A
N/A	Gutter Lip Ht (in)	N/A	N/A	Gutter X Slope (%)	N/A
N/A	Painted X Walk1?	No	N/A	Painted X Walk2?	N/A
	X Walk 1 Direction	To NE		X Walk 2 Direction	N/A
	X Walk 1 Width (in)	N/A		X Walk 2 Width (in)	N/A
	X Walk 1 Slope (%)	1.9		X Walk 2 Slope (%)	N/A

X Walk 1 X Slope (%)	1.6		X Walk 2 X Slope (%)	N/A
N/A	Ramp inside XWalk1?	N/A	N/A	Ramp inside XWalk2?	N/A
	Road Slope (%)	1.6		Clear Space?	N/A
	Road X Slope (%)	1.9	N/A	Clear Space to XWalk (in)	N/A
N/A	Any Obstructions?	N/A	N/A	Storm Grate/Utility Hazard?	N/A
	Obstruction Type		l	Storm Grate/Utility Type	
		N/A			N/A
			Yes	Surface Condition? (G/P)	Good
	Year and the second		No	Curb Slope (%)	13.3

Remove & Replace Curb Ramp With
Two New Directional Ramps or
Equivalent.
