Access Compliance Report

Public Rights-of-Way

(Curb Ramps)

Intersection ID: 9357	Main Street: N_POPLAR_ST	Cross Street: W_32ND_ST	Location: SW
ADA ID: 5FA2BD68436A	Ramp Type: Perp	Initial Pass/Fail: Fail	Overall Compliance: No
Severity Score: 22.5			
Codes/Mitigation Info/Possible Solution		Field Measurements/Component Compliance

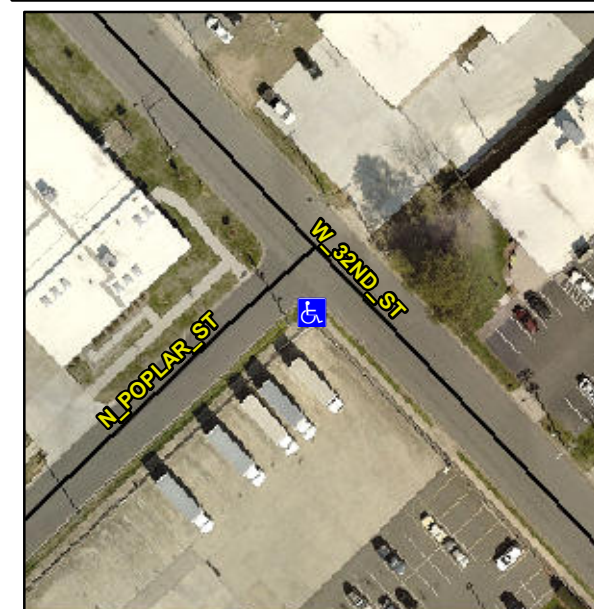
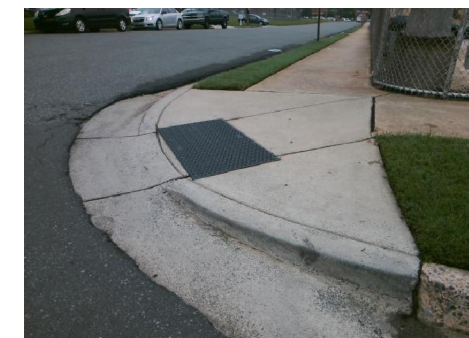
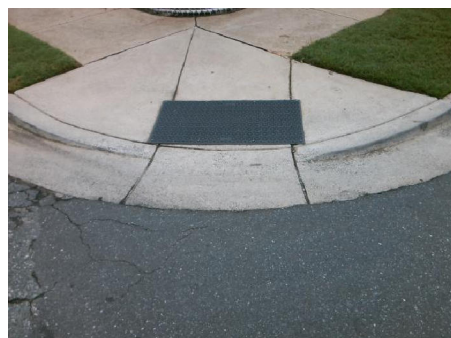
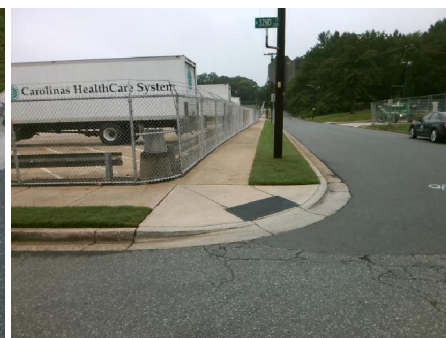
Not Found, R304.5.1, R304.2.2

Compliance	Description	Data	Compliance	Description	Data
N/A	Ramp Length (in)	58.0	No	Ramp Slope (%)	8.5
No	Ramp Width (in)	41.0	Yes	Ramp XSlope (%)	4.7
N/A	Flare Type LT	N/A	N/A	Flare Type RT	N/A
N/A	Flare Slope LT (%)	N/A	N/A	Flare Slope RT (%)	N/A
N/A	Flare Traversable LT?	N/A	N/A	Flare Traversable RT?	N/A
N/A	Landing Length (in)	N/A	N/A	DWS Provided?	N/A
N/A	Landing Width (in)	N/A	N/A	DWS Contrast?	N/A
N/A	Landing Slope (%)	N/A	N/A	DWS Length (in)	N/A
N/A	Landing X Slope (%)	N/A	N/A	DWS Full Width?	N/A
N/A	Landing Curb? (Y/N)	N/A	N/A	DWS Offset (in)	N/A
N/A	Shared Landing?	N/A			
N/A	Gutter Ponding?	N/A	N/A	Gutter Slope (%)	N/A
N/A	Gutter Lip Ht (in)	0.5	N/A	Gutter X Slope (%)	N/A
N/A	Painted X Walk1?	No	N/A	Painted X Walk2?	N/A
	X Walk 1 Direction	To NE		X Walk 2 Direction	N/A
N/A	X Walk 1 Width (in)	N/A	N/A	X Walk 2 Width (in)	N/A
	X Walk 1 Slope (%)	2.1		X Walk 2 Slope (%)	N/A
	X Walk 1 X Slope (%)	5.8		X Walk 2 X Slope (%)	N/A

N/A	Ramp inside XWalk1?	N/A	N/A	Ramp inside XWalk2?	N/A
	Road Slope (%)	N/A	N/A	Clear Space?	N/A
	Road X Slope (%)	N/A	N/A	Clear Space to XWalk (in)	N/A
N/A	Any Obstructions?	N/A	N/A	Storm Grate/Utility Hazard?	N/A
	Obstruction Type			Storm Grate/Utility Type	
		N/A			N/A
			Yes	Surface Condition? (G/P)	Good

Remove & Replace Entire Ramp.

Total Cost: \$ 1850.00
