# Access Compliance Report

## Public Rights-of-Way

Intersection ID: 10017066	Main Street: NEAL_RD	Cross Street: N/A	Location: E
ADA ID: 5FA793B5E84D	Ramp Type: PerpDiag	Initial Pass/Fail: Fail	Overall Compliance: No
Codes/Mitigation Info/Possible Solution		Field Measurements/Component Compliance	
Severity Score: 33.75

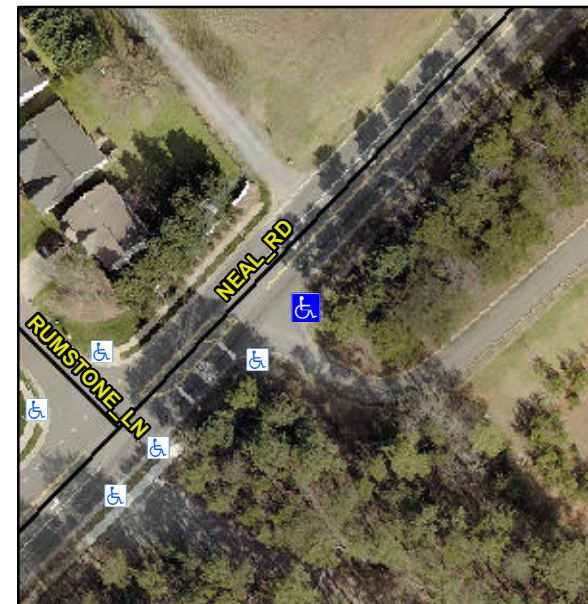
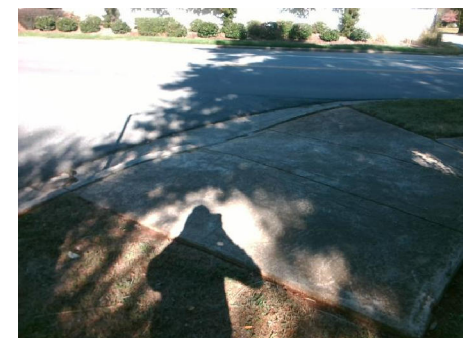
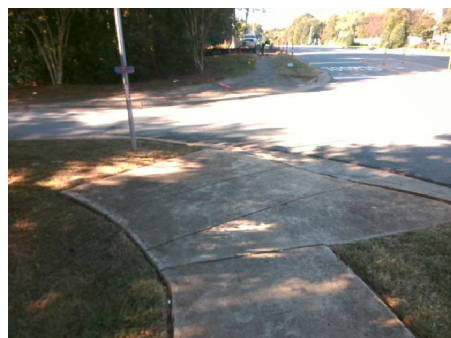
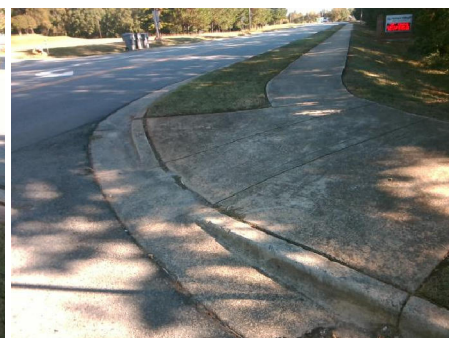
Compliance	Description	Data	Compliance	Description	Data
N/A	Ramp Length (in)	130.0	No	Ramp Slope (%)	12.0
No	Ramp Width (in)	38.0	Yes	Ramp XSlope (%)	1.7
N/A	Flare Type LT	N/A	N/A	Flare Type RT	N/A
N/A	Flare Slope LT (%)	N/A	N/A	Flare Slope RT (%)	N/A
N/A	Flare Traversable LT?	N/A	N/A	Flare Traversable RT?	N/A
N/A	Landing Length (in)	N/A	N/A	DWS Provided?	N/A
N/A	Landing Width (in)	N/A	N/A	DWS Contrast?	N/A
N/A	Landing Slope (%)	N/A	N/A	DWS Length (in)	N/A
N/A	Landing X Slope (%)	N/A	N/A	DWS Full Width?	N/A
N/A	Landing Curb? (Y/N)	N/A	N/A	DWS Offset (in)	N/A
N/A	Shared Landing?	N/A			
N/A	Gutter Ponding?	N/A	N/A	Gutter Slope (%)	N/A
N/A	Gutter Lip Ht (in)	N/A	N/A	Gutter X Slope (%)	N/A
N/A	Painted X Walk1?	No	N/A	Painted X Walk2?	No
	X Walk 1 Direction	To NW		X Walk 2 Direction	To SW
N/A	X Walk 1 Width (in)	N/A	N/A	X Walk 2 Width (in)	N/A
	X Walk 1 Slope (%)	7.3		X Walk 2 Slope (%)	3.1
	X Walk 1 X Slope (%)	2.9		X Walk 2 X Slope (%)	8.9

N/A	Ramp inside XWalk1?	N/A	N/A	Ramp inside XWalk2?	N/A
	Road Slope (%)	5.7	N/A	Clear Space?	N/A
	Road X Slope (%)	0.6	N/A	Clear Space to XWalk (in)	N/A
N/A	Any Obstructions?	N/A	N/A	Storm Grate/Utility Hazard?	N/A
	Obstruction Type			Storm Grate/Utility Type	
		N/A			N/A
			Yes	Surface Condition? (G/P)	Good

**Remove & Replace Curb Ramp With Two New Directional Ramps or Equivalent.**

**R304.5.1, R304.2.2**
