Access Compliance Report Public Rights-of-Way (Curb Ramps)

Intersection ID: N/A Main Street: ASCENSION_WY **Cross Street: HORACE_ST** Location: SW **Overall Compliance: No ADA ID: 5FADDAC42D6A** Ramp Type: Perp Initial Pass/Fail: Fail **Severity Score:** 12.5

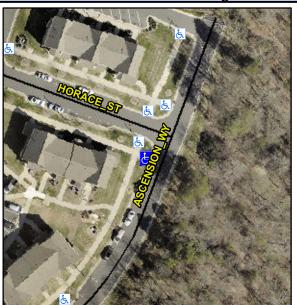
Field Measurements/Component Compliance								
Compliance Description		Data	Comp	liance Description	Data			
N/A	Ramp Length (in)	72.0	No	Ramp Slope (%)	9.5			
Yes	Ramp Width (in)	70.0	Yes	Ramp XSlope (%)	0.2			
N/A	Flare Type LT	N/A	N/A	Flare Type RT	N/A			
N/A	Flare Slope LT (%)	N/A	N/A	Flare Slope RT (%)	N/A			
N/A	Flare Traversable LT?	N/A	N/A	Flare Traversable RT?	N/A			
N/A	Landing Length (in)	N/A	N/A	DWS Provided?	N/A			
N/A	Landing Width (in)	N/A	N/A	DWS Contrast?	N/A			
N/A	Landing Slope (%)	N/A	N/A	DWS Length (in)	N/A			
N/A	Landing X Slope (%)	N/A	N/A	DWS Full Width?	N/A			
N/A	Landing Curb? (Y/N)	N/A	N/A	DWS Offset (in)	N/A			
N/A	Shared Landing?	N/A						
N/A	Gutter Ponding?	N/A	N/A	Gutter Slope (%)	N/A			
N/A	Gutter Lip Ht (in)	N/A	N/A	Gutter X Slope (%)	N/A			
N/A	Painted X Walk1?	No	N/A	Painted X Walk2?	N/A			
	X Walk 1 Direction	To SE		X Walk 2 Direction	N/A			
N/A	X Walk 1 Width (in)	N/A	N/A	X Walk 2 Width (in)	N/A

9	Possible Solutions:
S. C. S.	Remove & Replace Entire Ramp.
*	Surveyor Notes:
一年 一年	N/A
Sept.	PROW/ADA:
The same of the sa	R304.2.2
