# Access Compliance Report

## Public Rights-of-Way

### (Curb Ramps)

| Intersection ID: 47840 | Main Street: PECO_RD | Cross Street: CACTUS_VALLEY_RD | Location: NE |

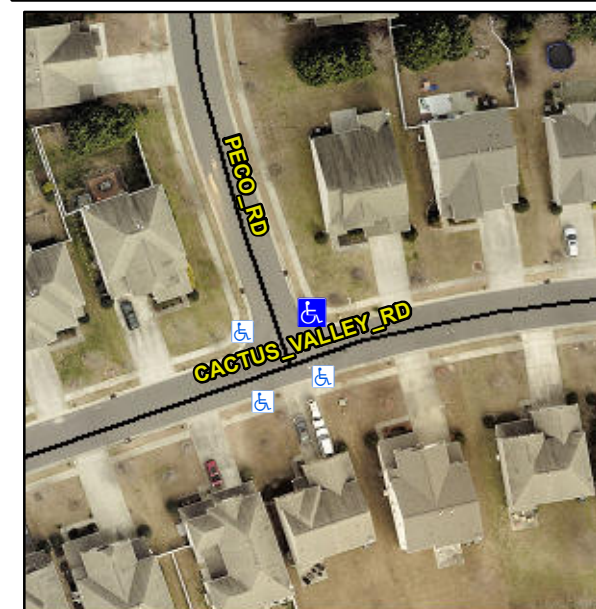
| ADA ID: 5FB1FF886085 | Ramp Type: BlendTrans2 | Initial Pass/Fail: Fail | Overall Compliance: No |
| Severity Score: 8.75 | | | |

**Not Found, R304.5.1**

| Compliance | Description | Data | Compliance | Description | Data |
|---|---|---|---|---|---|
| No | Ramp Width (in) | 47.0 | Yes | BlendTrans XSlope (%) | 1.2 |

**Remove & Replace Curb Ramp With Two New Directional Ramps or Equivalent.**

Total Cost: \$ 3200.00

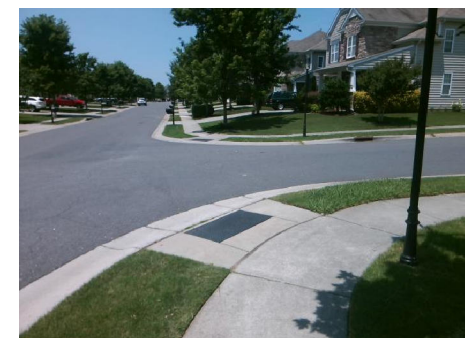
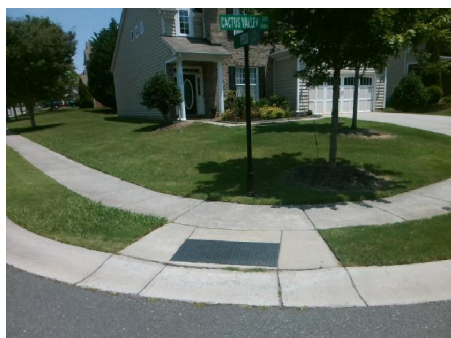
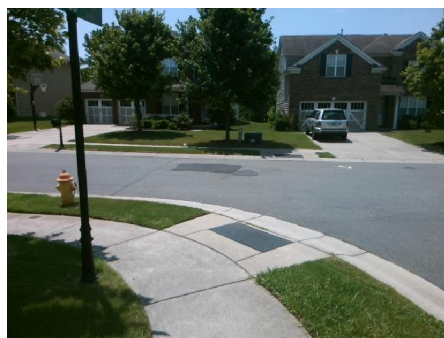
| Compliance | Description | Data | Compliance | Description | Data |
|---|---|---|---|---|---|
| | | | No | Curb Slope (%) | 6.7 |
